Flood of June 2003 in Southwest-Central Florida

Background

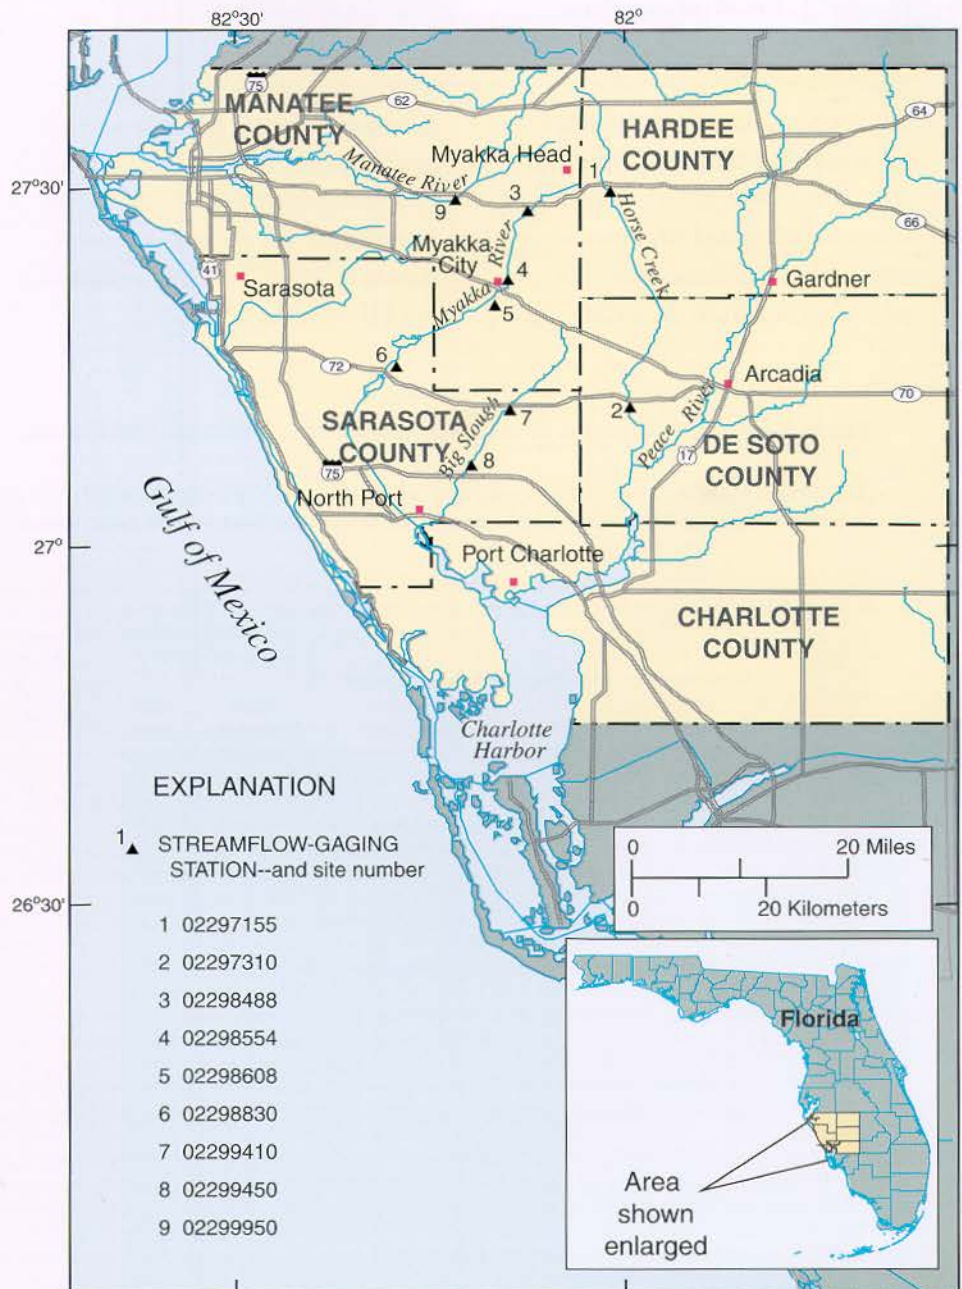
Figure 1—Geographic and hydrologic features in southwest-central Florida. Triangles locate U.S. Geological Survey streamflow-gaging stations.

Western De Soto, western Hardee, Manatee, and Sarasota Counties are drained by the Horse Creek, Manatee River, and Myakka River systems. Water in these watersheds flows southwestward to Charlotte Harbor and the Gulf of Mexico (fig. 1).

Information on peak discharges for selected gaging stations (fig. 1) in southwest-central Florida is shown in table 1. The data include peak discharge, peak stage, recurrence interval, gaging-station period of record, and date and magnitude of the largest historical peak discharge recorded prior to June 2003.

The June flooding caused by localized runoff was most severe in the Myakka and Manatee River Basins. Peak discharges for the period of record were 7,800 cubic feet per second (ft^3/s) at Myakka River upstream from Youngs Creek near Myakka City (site 3, fig. 1, table 1) and 9,270 ft^3/s at Myakka River near Myakka City (site 4, fig. 1, table 1). Discharge peaked at Myakka River at Myakka City (site 5, fig. 1, table 1) at 10,800 ft^3/s , the second highest flow on record and the highest since 1992. The flood wave continued downstream to Myakka River near Sarasota (site 6, fig. 1, table 1) where 11,100 ft^3/s was recorded. This discharge was also the highest for the period of record, which began in 1936. USGS field crews observed discharge at this site flowing over State Highway 72 near Myakka River State Park. The highest discharge ever recorded on Manatee River (11,700 ft^3/s) occurred near Myakka Head (site 9, fig. 1, table 1). Discharge at this site increased more than 11,000 ft^3/s in 24 hours on June 21-22, after more than 10 inches of precipitation fell in 48 hours (fig. 2).

Flooding also occurred in the Horse Creek and Big Slough watersheds. A peak discharge of 3,610 ft^3/s for the period of record was recorded at Horse Creek near Myakka Head (site 1, fig. 1, table 1). At State Highway 72, the

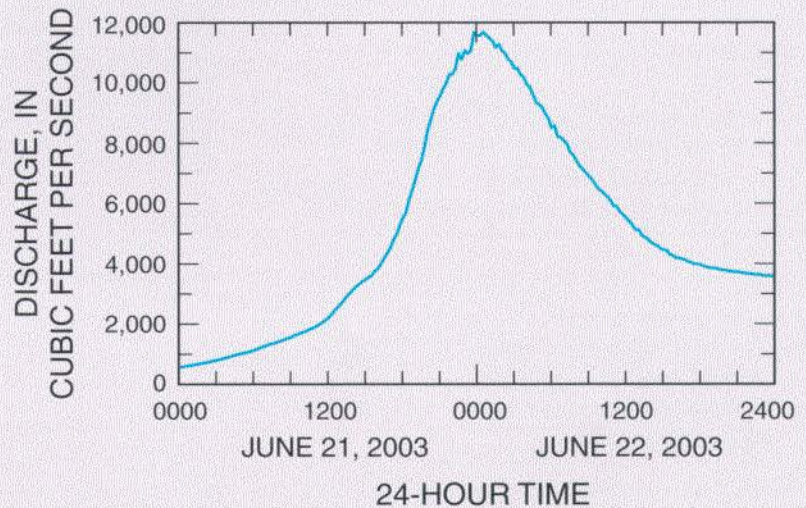
Figure 2—Manatee River near Myakka Head, Florida (02299950, site 9, fig. 1, table 1). Computed discharge, in cubic feet per second. These data are provisional and subject to revision.

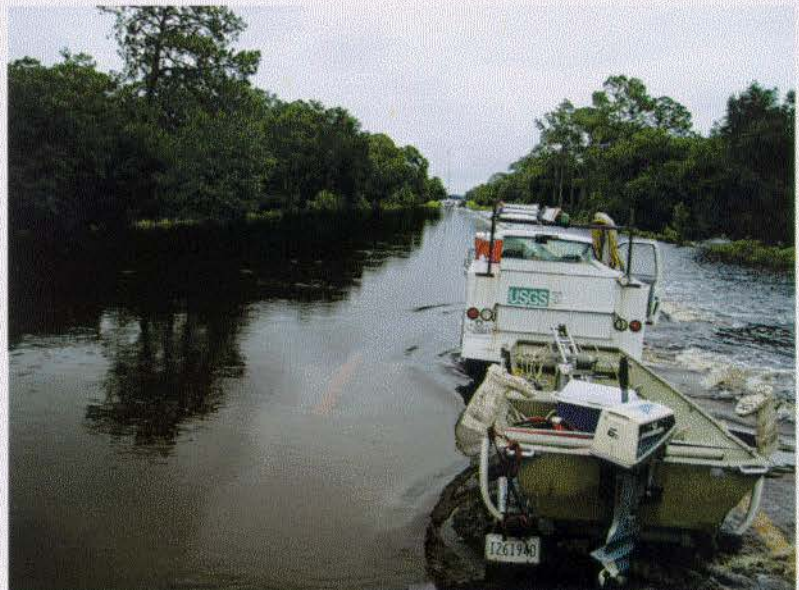
Figure 3—View of road overflow at discharge of 9,900 ft^3/s in Horse Creek near Arcadia (site 2, fig. 1, table 1) on June 23, 2003.

discharge for Horse Creek near Arcadia (site 2, fig. 1, table 1) was observed overflowing the road by USGS field crews (fig. 3). The peak discharge of 11,000 ft^3/s was the second highest flow recorded since 1950 and the highest since Hurricane Donna in 1960.

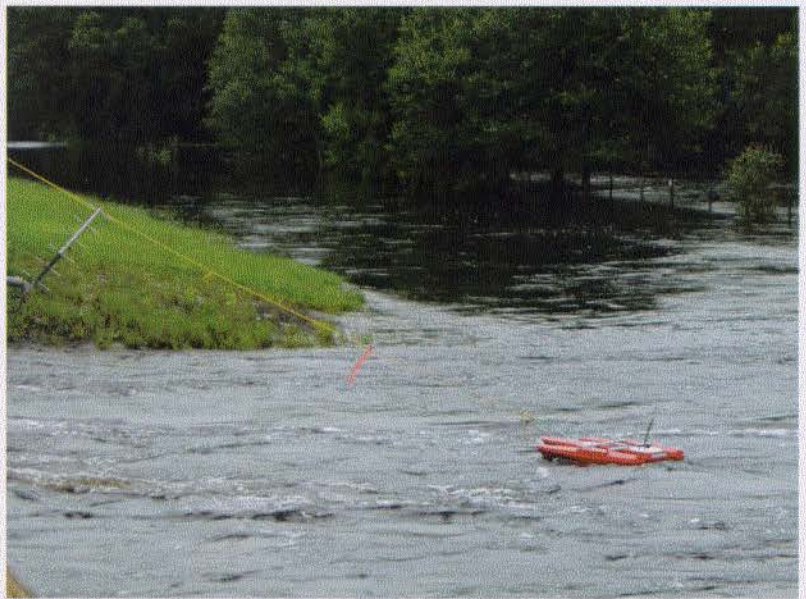
Figure 4—View of Big Slough Canal near Myakka City (site 7, fig. 1, table 1). Discharge measurement being made using a tethered boat and acoustic doppler current profiler.

At Big Slough Canal near Myakka City (site 7, fig. 1, table 1), a discharge of 7,180 ft^3/s was the highest recorded since 1992 and second highest for the period of record. Flow measurements at site 7 were made using an acoustic doppler current profiler on a tethered

boat (fig. 4). Flooding continued downstream and was most severe in the City of North Port, where the Big Slough Canal overflowed its banks at Tropicaire Boulevard (fig. 5; site 8, fig. 1, table 1). The peak discharge of 4,950 ft³/s was the highest recorded for the period of record at site 8.

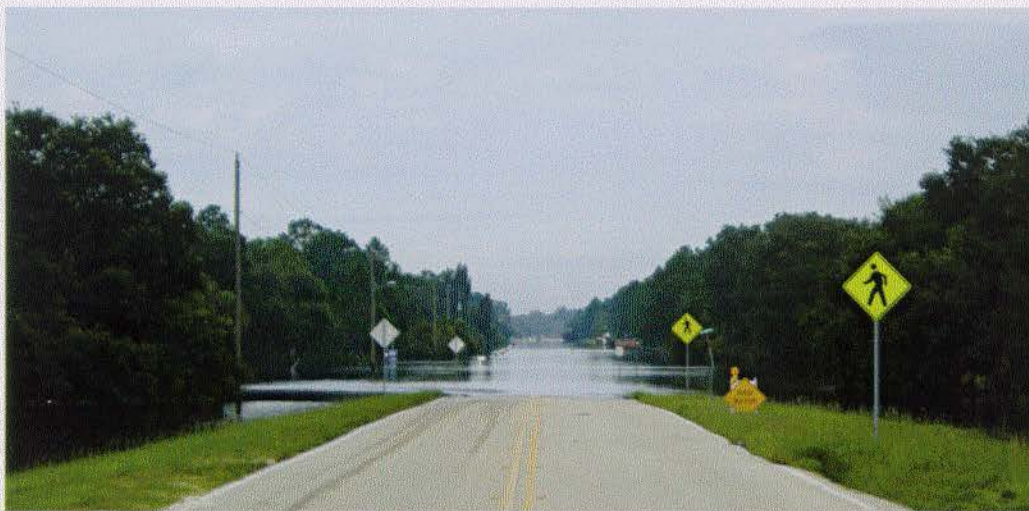
Figure 5—View of road overflow at discharge of 4,450 ft³/s, Big Slough Canal at Tropicaire Boulevard near North Port (site 8, fig. 1, table 1) on June 24, 2003.
