Inventory and Assessment of Hydrologic Alterations in the Myakka River Watershed

By: Stephen M. Suau, P.E.

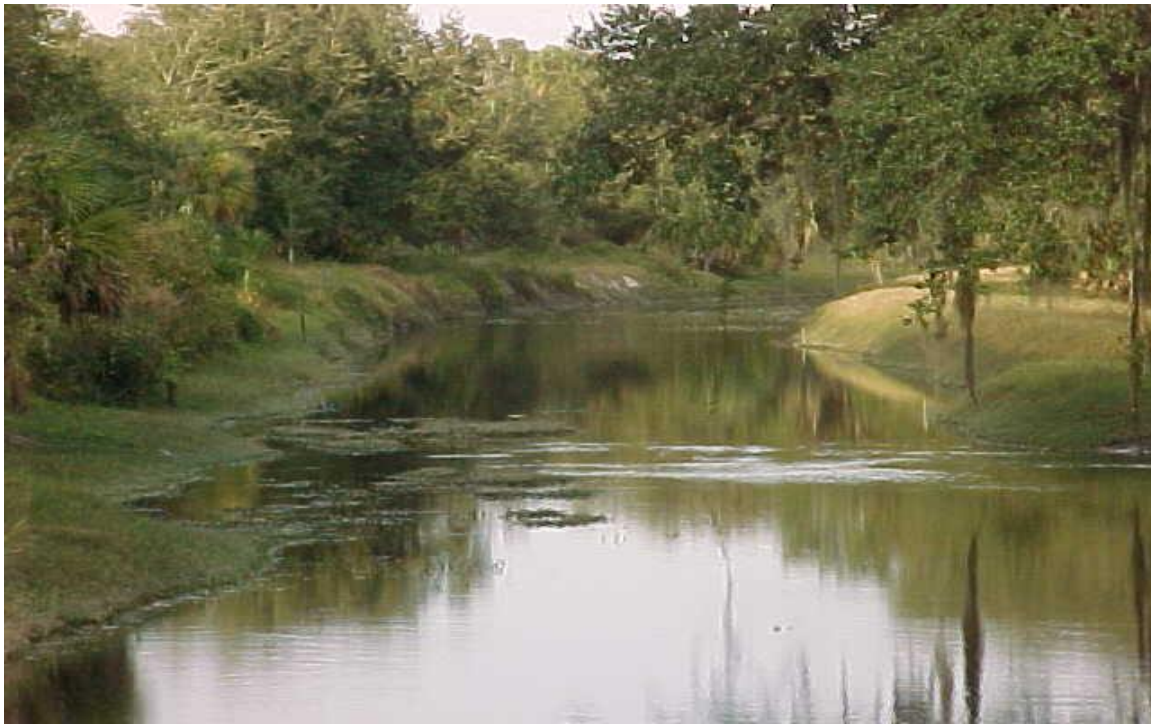
Figure 3.1 – Clay Gully

Gully route to the Upper Myakka Lake is less than half of the travel length of the Myakka River. Figure 3.1 presents the current configuration of Clay Gully.

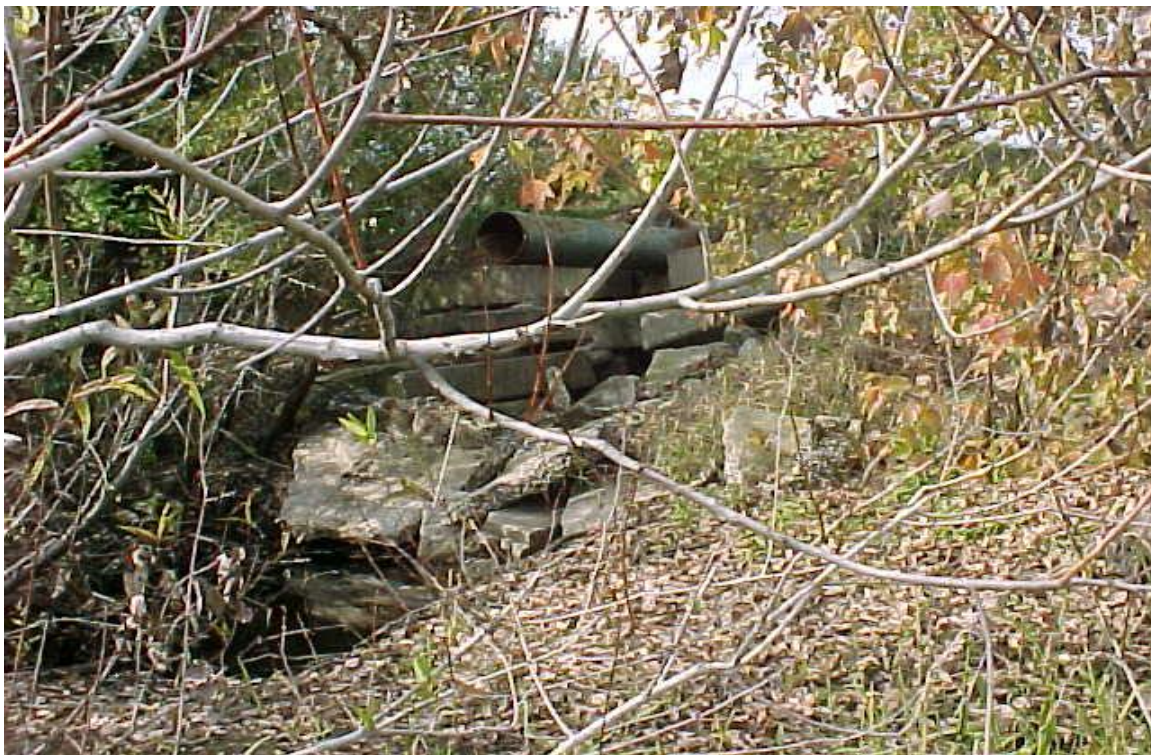
Figure 4.1 – Hidden River Dike w/Outfall

“Mr. Smith’s original intention was to raise cattle. Recognizing that a portion of the property was ‘waterlogged’, he contracted the Soil Conservation, who decided to put his property into their conservation program constructing the dike, by-pass canals and the drainage system throughout what is now Hidden River” (refer to Figure 4.1).

The cattle ranch “protected” by the dike was subsequently platted as a residential subdivision in 1966. A recent survey indicates a low point in the top elevation of the dike

at 21.66 msl. Flood stages determined by the USGS adjacent to the Hidden River dike are 18.9, 19.5, 19.9, 20.6, 21.0, 21.4, 21.8, and 22.4 feet above msl, for the 2, 5, 10, 25, 50, 100, 200, and 500 year frequency floods, respectively. Therefore, this dike affects all flow regimes that would normally come out of bank along the north side of the river.

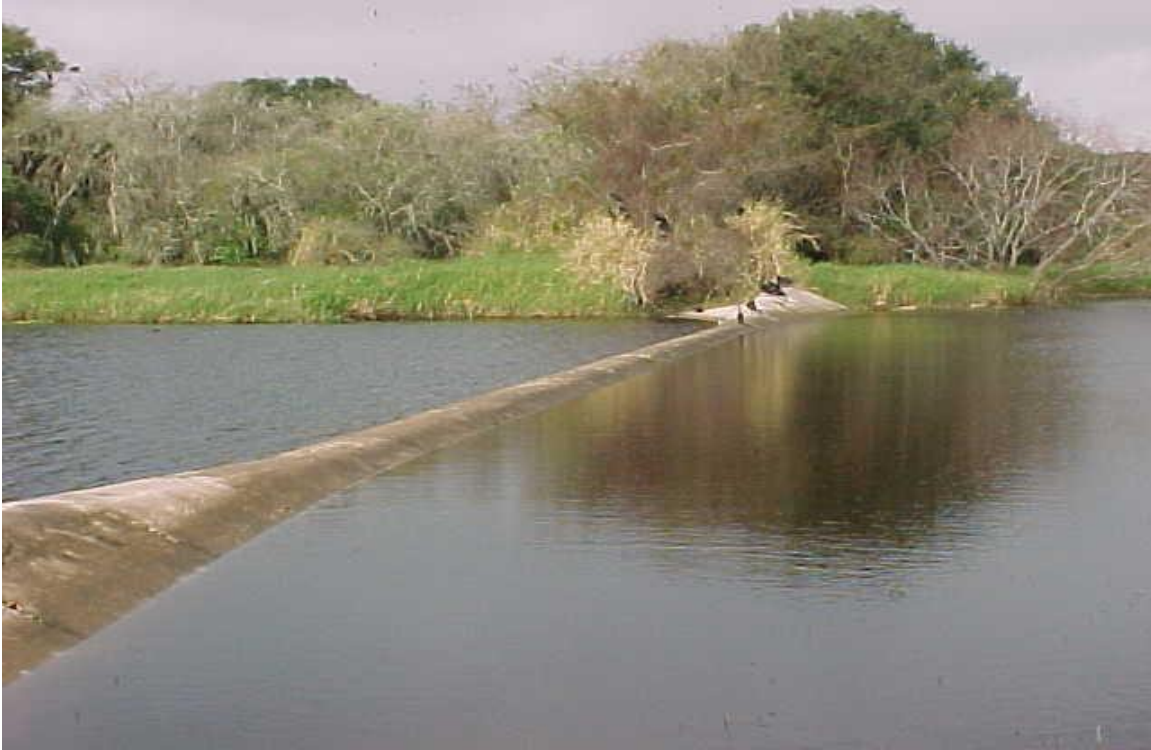
Figure 5.1

The dam located at the main outfall to the Upper Myakka Lake was constructed in the spring of 1941 (refer to Figure 5.1), replacing a dam that had been constructed several years earlier by the Civilian Conservation Corps (CCC). The construction of this dam resulted in a backwater effect into both Howard Creek and Vanderipe Slough. A dike was therefore constructed along the north side of Vanderipe Slough. The construction of the dam precipitated an engineering study being conducted in 1945 by Robert Angas on behalf of the Florida Forest and Park Service to address flooding concerns expressed by upstream private property owners. This engineering study was to “determine the damage, if any, caused to the Carlton Pastures (subsequently Hidden River subdivision) by backwater from the dam at the outlet of the Upper Myakka Lake. In addition, the study was to determine what damage, if any, was being done to the pastures of Mrs. John Vanderipe, Sr. by the dam”.

The crest of the dam is at 13.65 feet above msl. At this crest, approximately 2,935 acre-feet of storage are impounded in the Upper Lake. Based upon an upstream contributing drainage area of approximately 229 square miles, this volume would correspond to 0.24 inch of runoff over the contributing area.

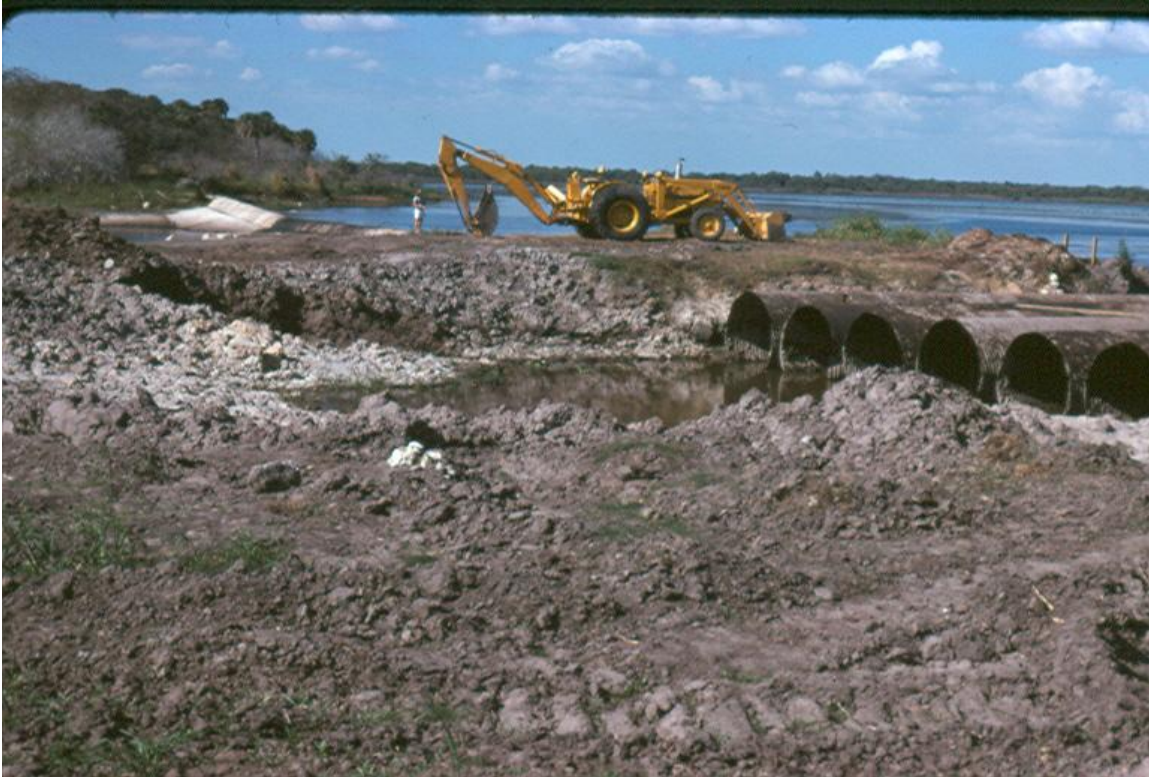
As previously indicated, installation of the dam on the Upper Myakka Lake was somewhat controversial, causing the construction of the dike north of Vanderipe Slough. In following years, several other dikes were installed in the floodplain of the Myakka River, upstream of the Upper Myakka Lake. In 1974, coincidentally the same year that an extensive dike system was constructed in Tatum Sawgrass, six (6), 60" diameter pipes were constructed just southeast of the Upper Myakka Lake dam to allow for the drawdown of lake (refer to Figure 6.1).

Figure 6.1 - Upper Myakka Lake Culvert Installation, November, 1974

The inverts of these pipes vary between 9.6 and 9.8 msl. There are approximately 2,935 acre-feet of storage in the Upper Myakka Lake between the crest of the spillway and the inverts of the pipes. Therefore, installation of the pipes would equate to an average discharge rate during the 135 day season (from January 1 to May 15) of approximately 7 mgd.

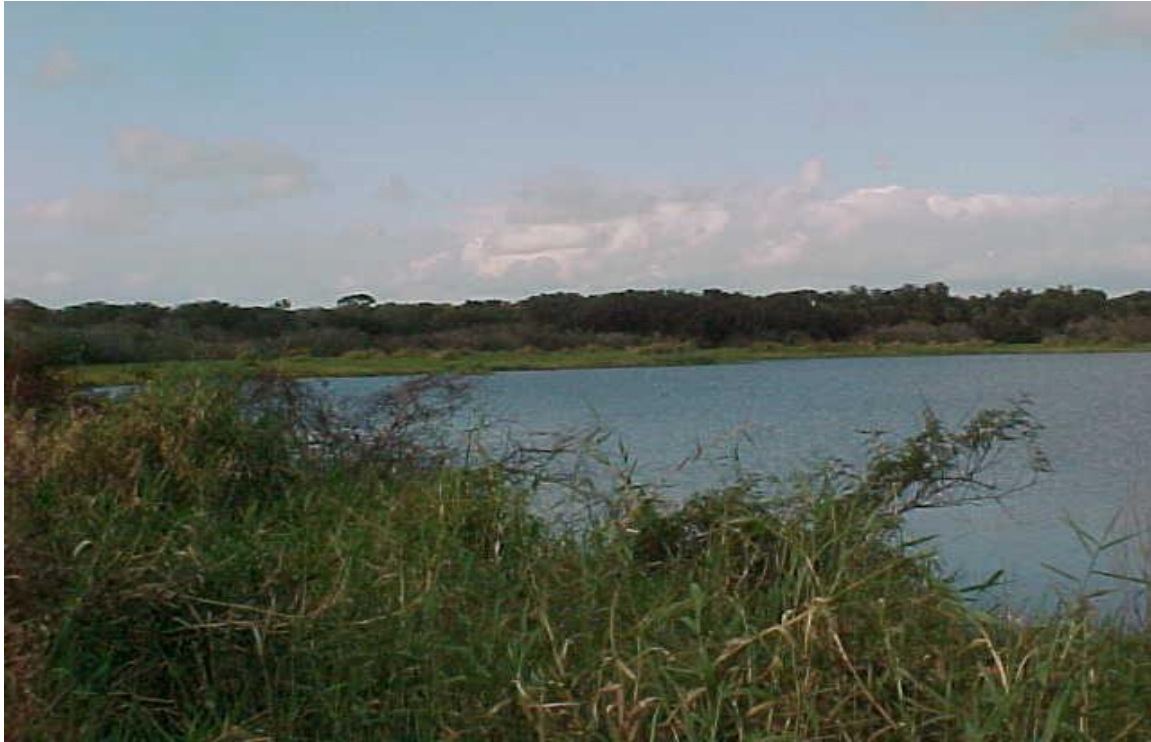
Howard Creek is located in Sarasota County and enters the Upper Myakka Lake north of the Vanderipe Slough dike. Figure 7.1 provides a picture taken from the Vanderipe Slough dike, looking north where Howard Creek enters the Upper Myakka Lake. Before the construction of the Vanderipe Slough dike, Howard Creek may have drained, or at least contributed flows to, Vanderipe Slough. The watershed served by Howard Creek has been predominately in agricultural use since the 1950's. Since 1990, treated reclaimed wastewater has been used to irrigate agricultural operations totaling between 4,792 and 5,642 acres. Long term rainfall and stream gage information from the USGS and rainfall and wastewater irrigation quantities from Hi-Hat and the City of Sarasota were used to determine if the reclaimed irrigation water was having an effect on flows from Howard Creek to the Upper Myakka Lake.

Figure 7.1 – Upper Myakka Lake and Howard Creek from Vanderipe Slough Dike

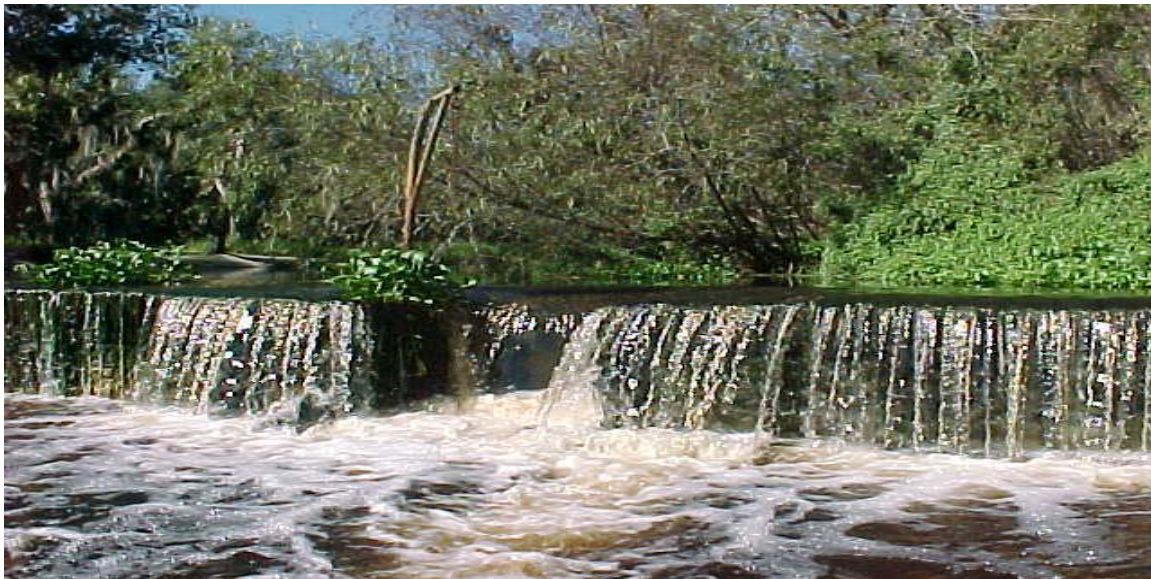
Down's Dam was reportedly constructed in the 1930's (1983 Clarence Sumerall interview). This concrete dam has a 5 foot wide by 4 foot high notch that is operated by the underlying property owner. In the dry season a thick piece of plywood is placed on the upstream side of the structure and held in place by the water pressure (refer to Figure 9.1). The water level is controlled by the top of the structure elevation of 10.6 msl in the dry seasons. The plywood is removed in the wet season, allowing the upstream water levels to drop as much as four (4) feet and exposing the notch invert at 6.6 msl.

Figure 9.1 – Downs Dam during Dry Season

During the dry season, operation of this dam at 10.6 msl is effective in impounding water in the Lower Myakka Lake. In his 1945 engineering report to Florida Forest and Park Service, Robert Angus proposed that a dam with a spillway crest elevation of 10 msl be constructed at the outlet of the Lower Myakka Lake. At 10.6 msl, approximately 1000 acre-feet are stored in the Lower Myakka Lake.

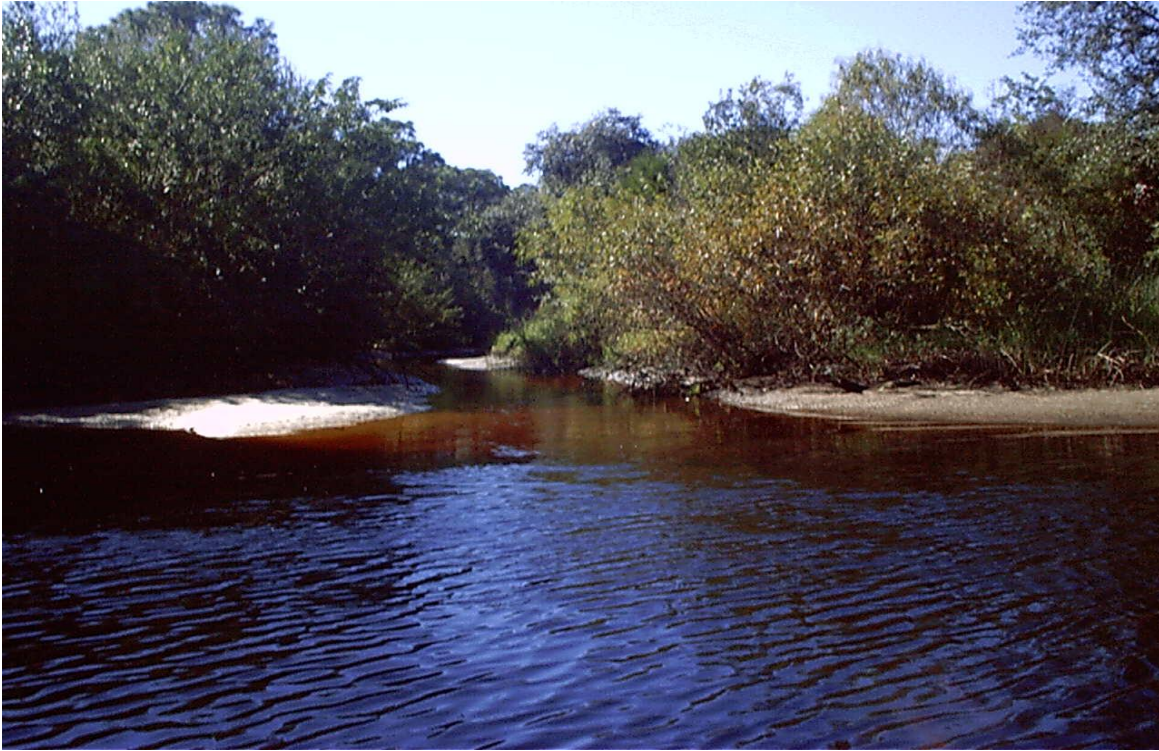
The Blackburn Canal extends approximately 6 miles from its confluence with the Myakka River to Roberts Bay and was designed to relieve flooding on the Myakka River on behalf of private property interests in 1959. According to the original engineering report prepared by DeLew, Cather and Brill, Blackburn Canal was designed to convey approximately 800 cfs for the 50-year frequency flood event. This canal was excavated at or below sea level from the Myakka River, west to Curry Creek. Curry Creek, once a relatively short, natural coastal creek, was straightened and deepened to provide for an adequate hydraulic connection with Blackburn Canal. Figure 11.1 shows the east end of Blackburn Canal at its confluence with the Myakka River.

Figure 11.1 – Blackburn Canal at Confluence with Myakka River

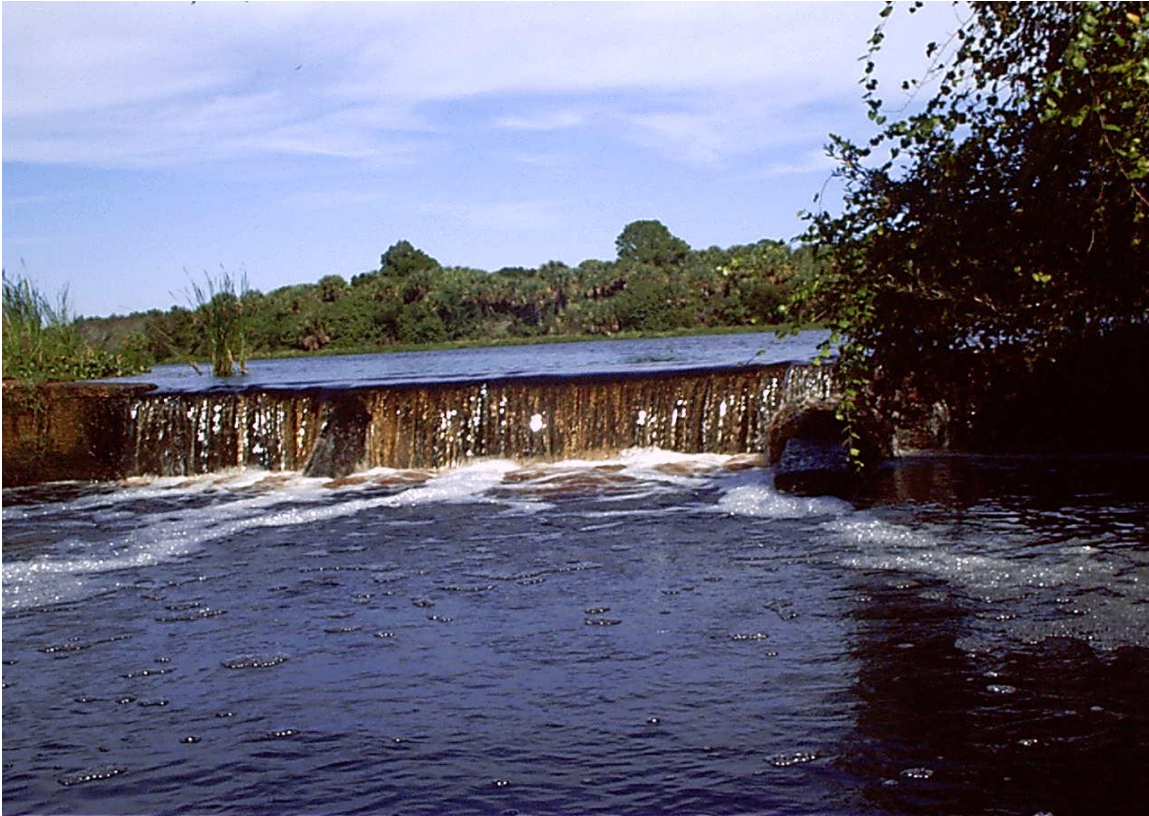
Sometime in the 1950's a dam was placed in Deer Prairie Creek (refer to Figure 12.1). This dam is still in place and with a crest elevation of 3.31 msl, it essentially acts as a salinity barrier. It is estimated that this dam impounds approximately 8.25 acres. Assuming an artificial impoundment depth of 4 feet and a contributing drainage area of approximately 33,234.26 acres, this would equate to 13.24 acre-feet which corresponds to less than 0.01 inches of runoff over the contributing upstream drainage area. This dam probably effects low flows, but has a minimal effect on normal and high flows from the Deer Prairie Creek watershed.

Figure 12.1 – Deer Prairie Creek Dam

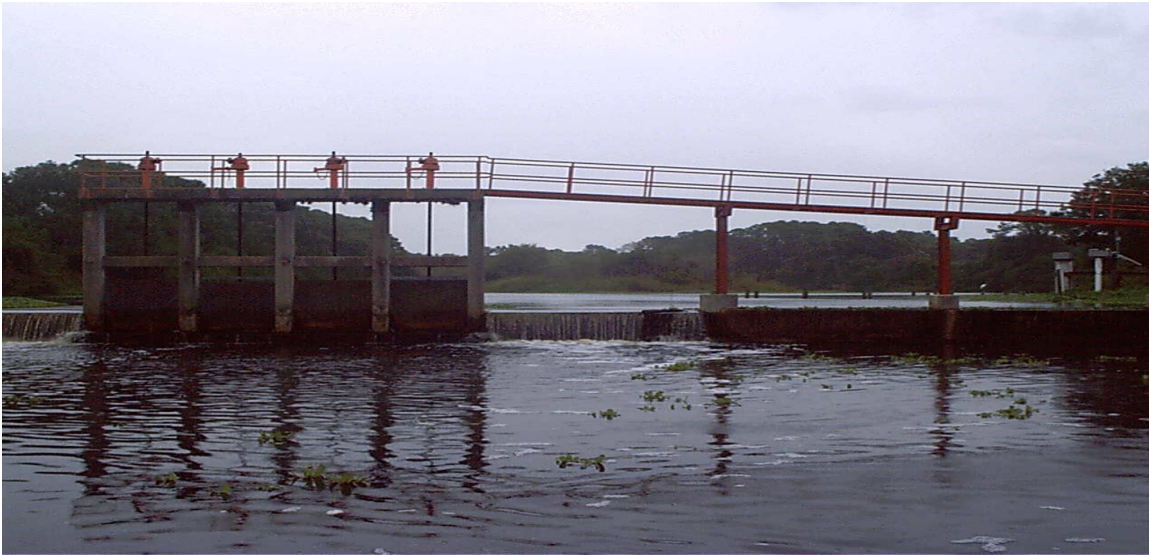
limit of the natural Myakkahatchee Creek (based upon the 1847 survey). It impounds some flow and is used by the City of North Port for public water supply. This dam is presented in Figure 13.1.

Figure 13.1 – Big Slough Dam
