### 3.0 Cumulative Impacts to Water Resources

The *Peace River Cumulative Impact Study* identified 22 major impacts to water resources, summarized in the table below. Note that agricultural land uses today comprise approximately 80% of the Peace River basin while urban and mining land uses each cover roughly 10%.

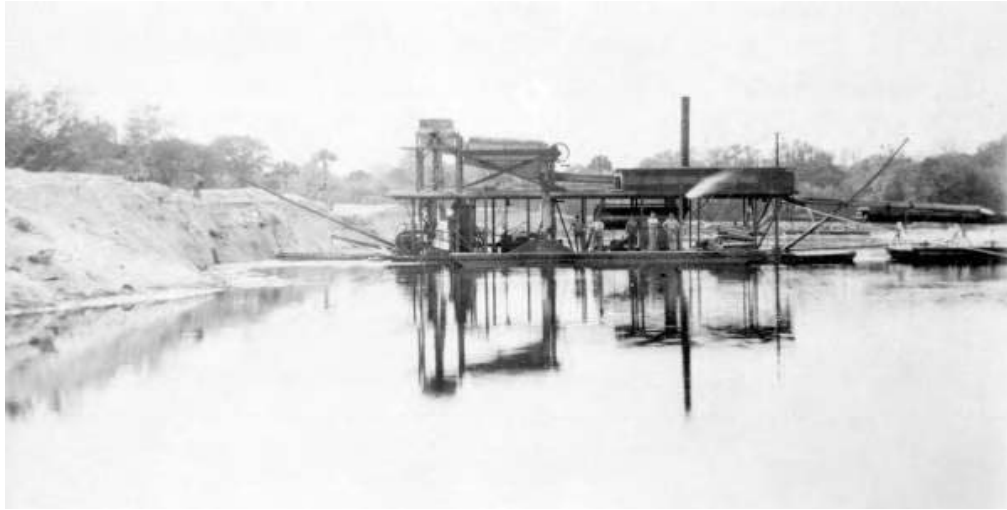
Figure 3.13 Early 1900s Phosphate Dredge on Upper Peace River (Florida Archives)

Early phosphate mining in the upper Peace River watershed altered surface drainage patterns and the surface water/groundwater relationships of the river and its tributaries. Although most of the mining in the watershed has occurred since the 1940s, phosphate pebble was mined from the channel of the Peace River during the late 1800s (Figures 3.13 and 3.14) and many lands were mined before Florida first required land reclamation in 1975.

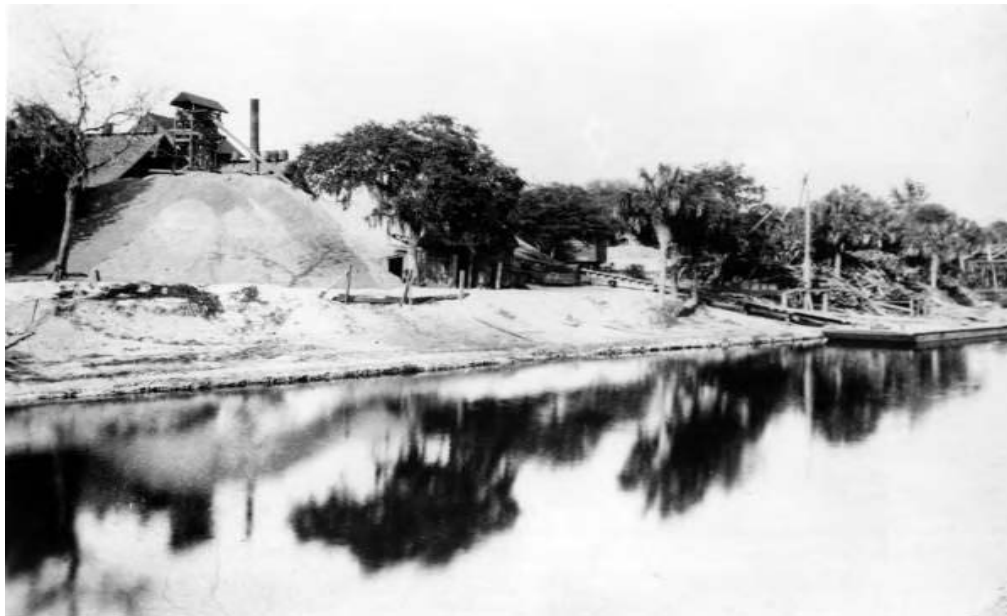
Figure 3.14 1890s Phosphate Mine in Ft. Meade (Florida Archives)

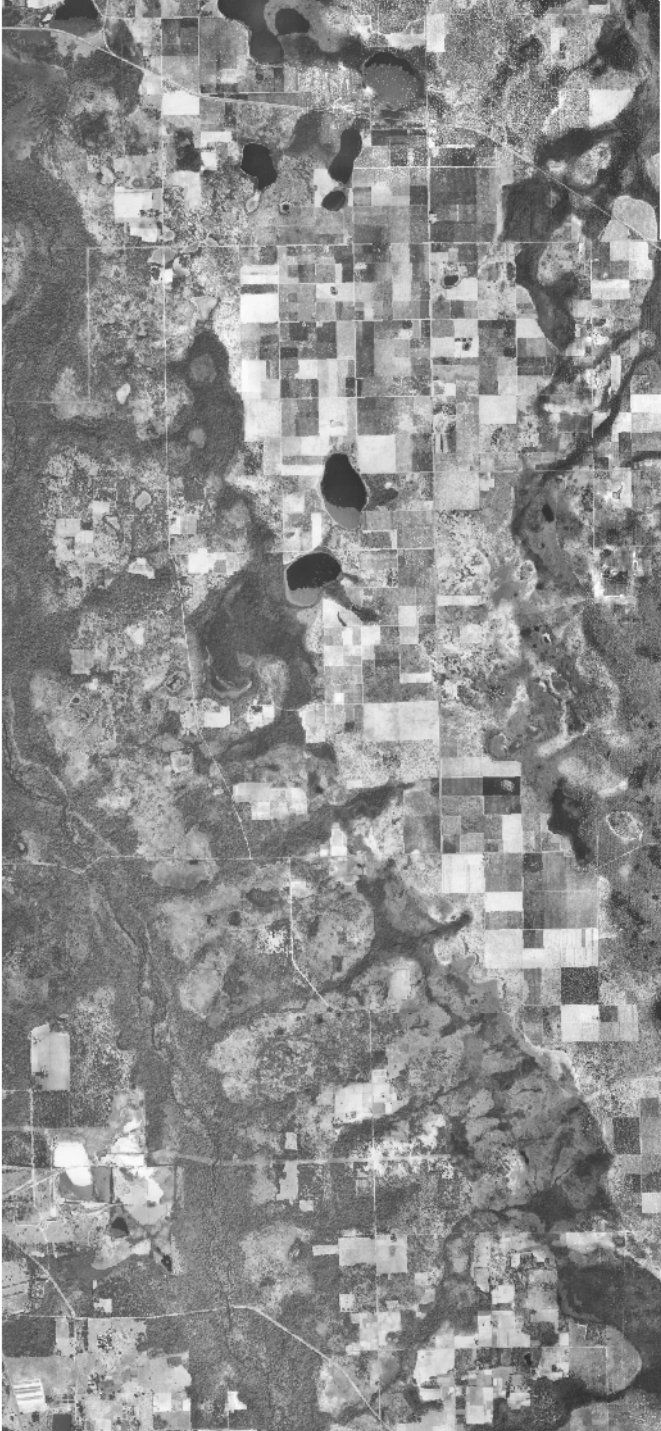
**Figure 3.1**

# East of Peace River between Bartow and Fort Meade Comparison

1940s Aerial

2004 Aerial

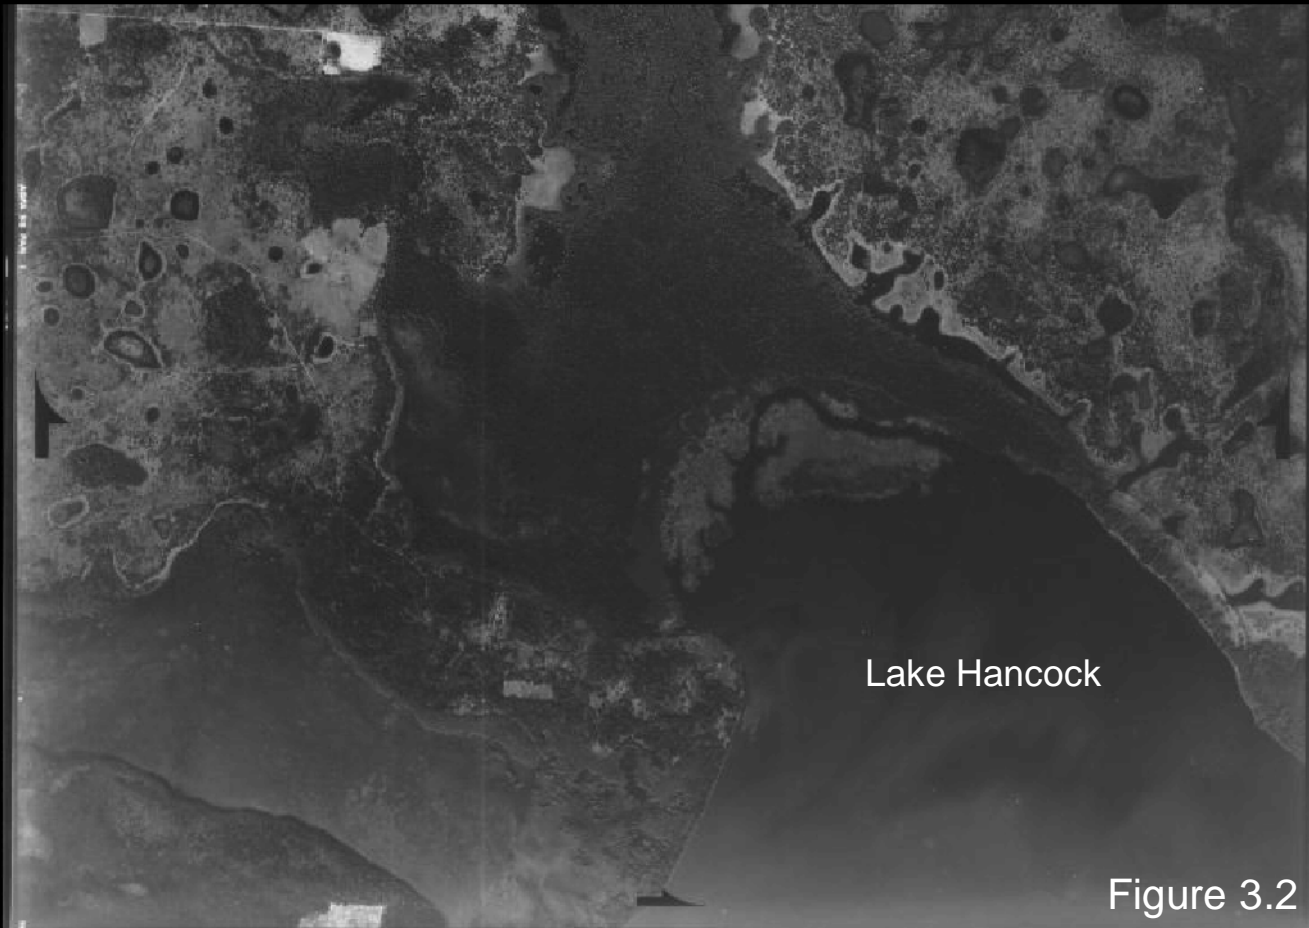
# 1941 Aerial

## 1941 - North Lake Hancock/Unimpacted South-Central Saddle Creek

Mining in the basin has also resulted in elimination and canalization of streams. Most streams lost to mining were first- and second-order systems. On the east side of the Peace River between Peace Creek canal in the north and Rocky Branch to the south, an extensive series of Peace River tributary streams and headwater bayhead wetlands that formerly existed along the west side of the Winter Haven Ridge were totally eliminated and replaced mostly by clay settling areas (Figure 3.1). Saddle Creek north of Lake Hancock was channelized to facilitate mining operations as they expanded northward along the western side of the creek floodplain (Figures 3.2 through 3.7).

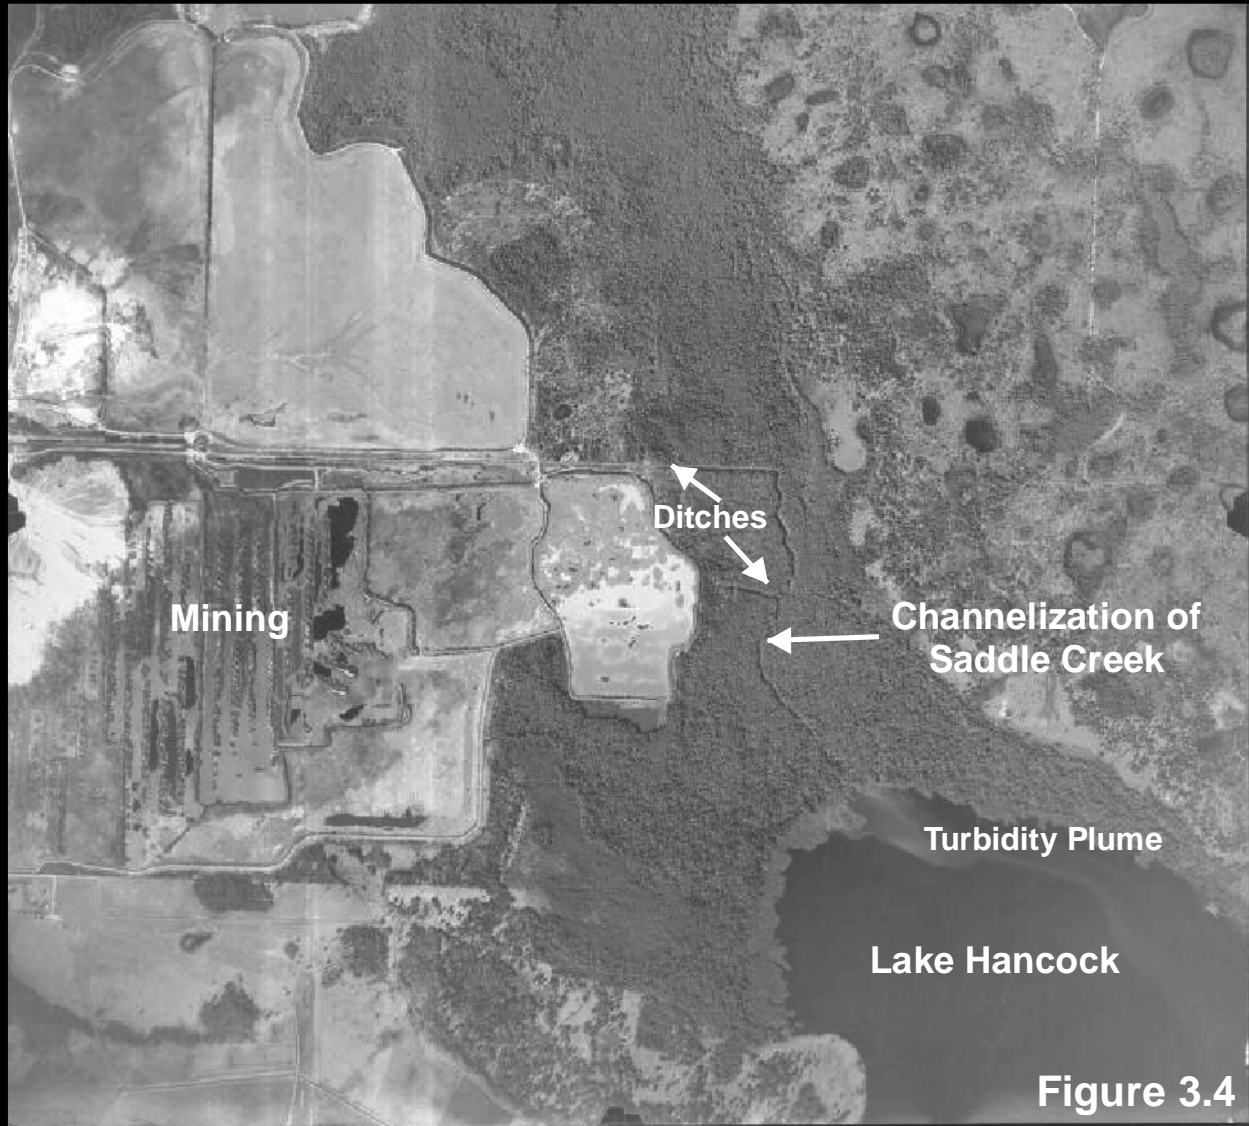
Figure 3.4

## 1958 - North Lake Hancock/Channelized South-Central Saddle Creek/Mining/Turbidity Plume

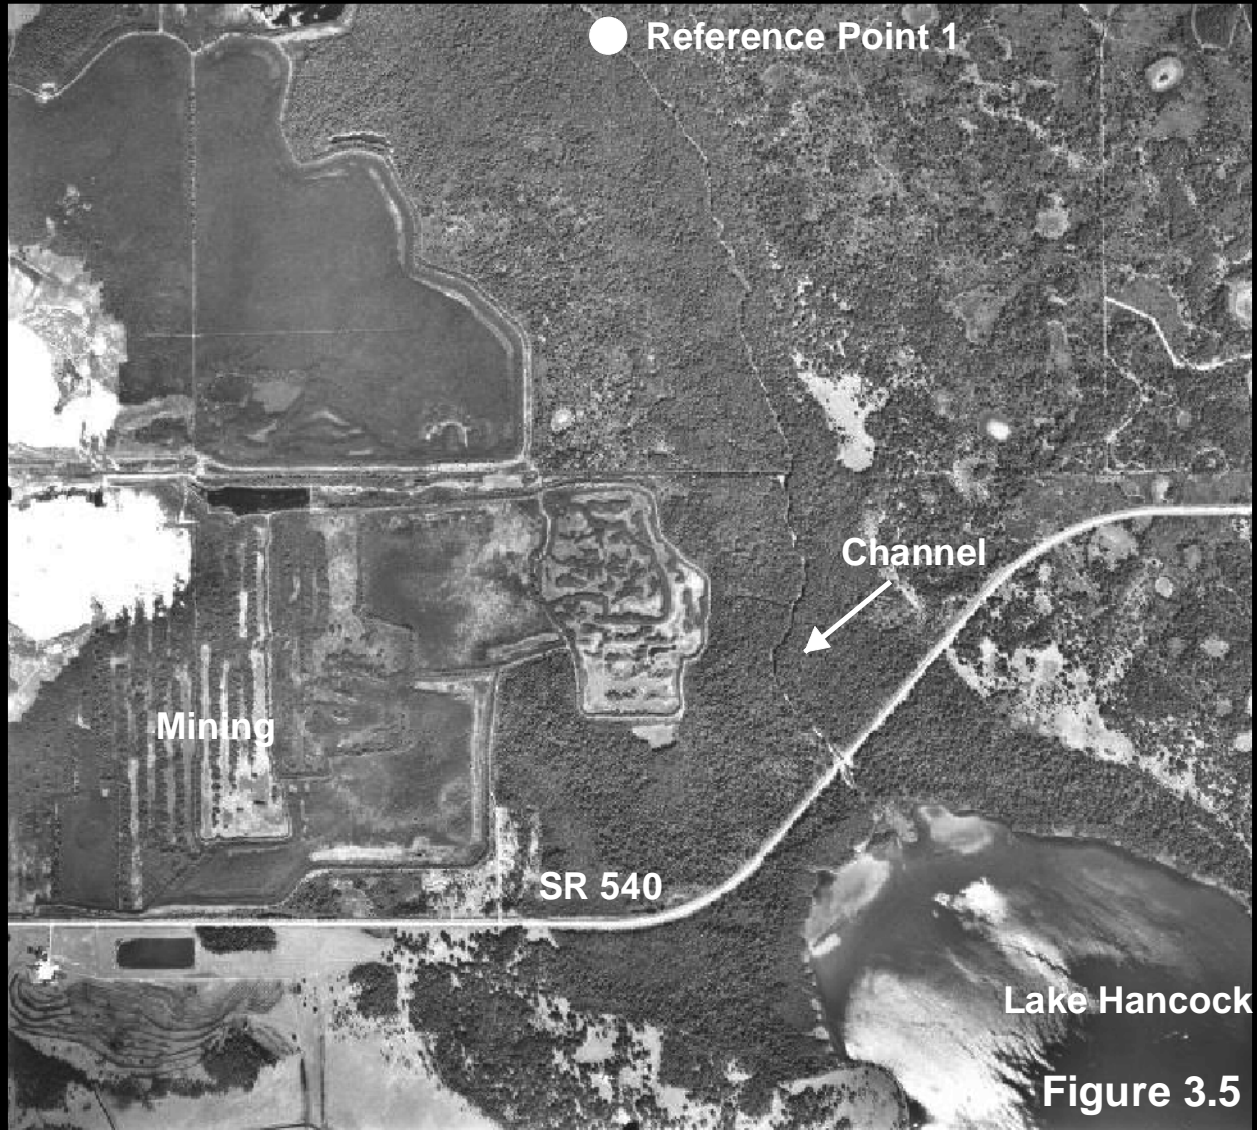
## 1968 - North Lake Hancock/Channelized South-Central Saddle Creek/Mining/State Road 540

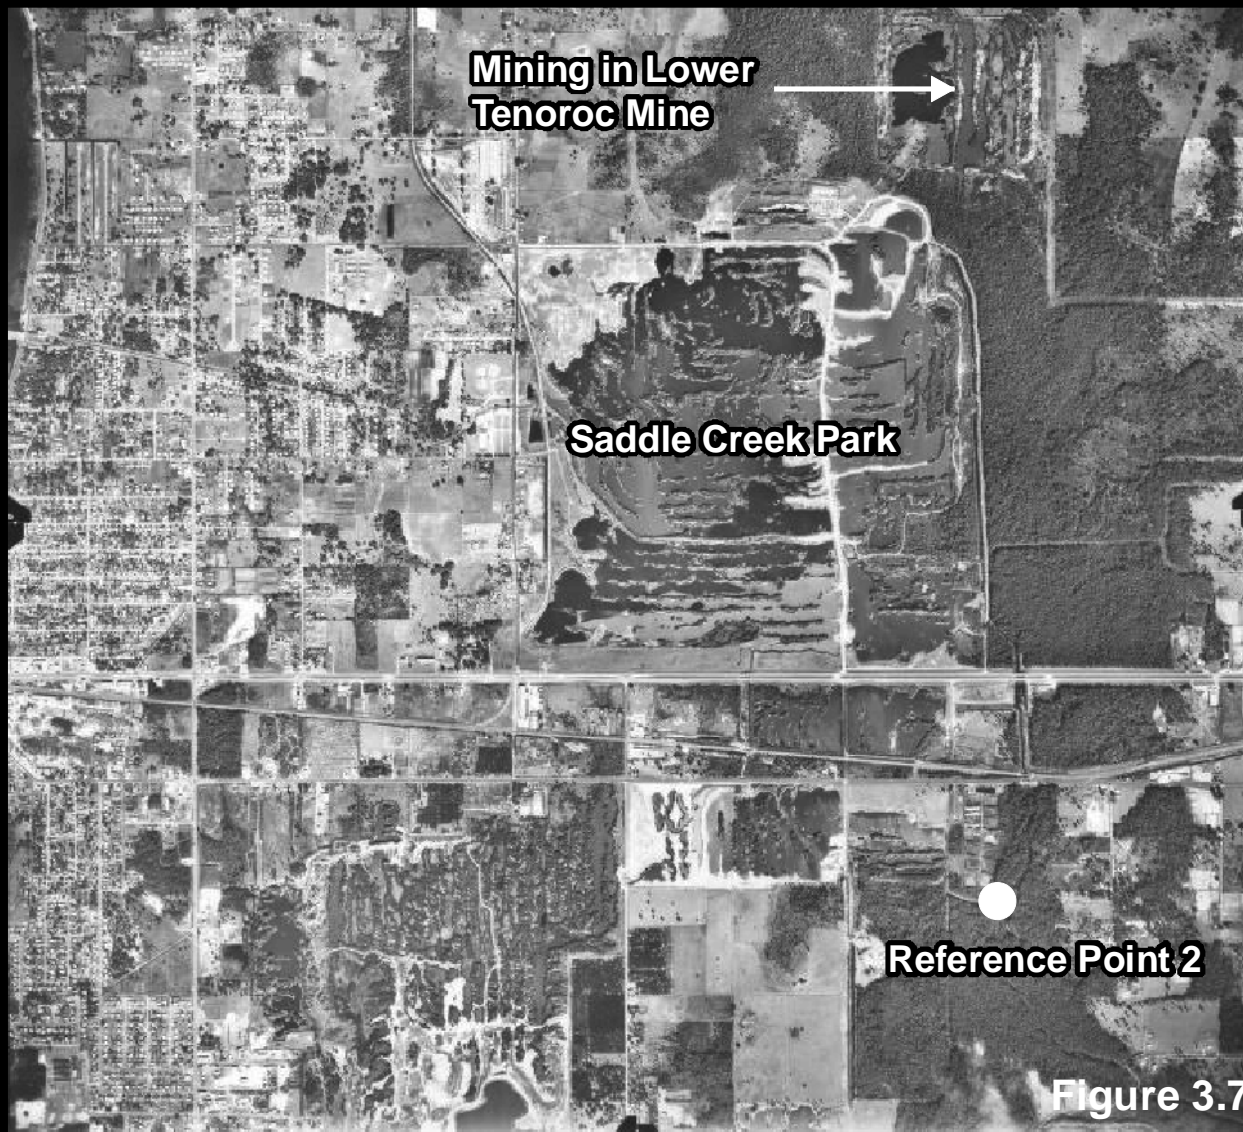
## 1968 - Channelized Northern Saddle Creek/ Mining in Lower Tenoroc Mine

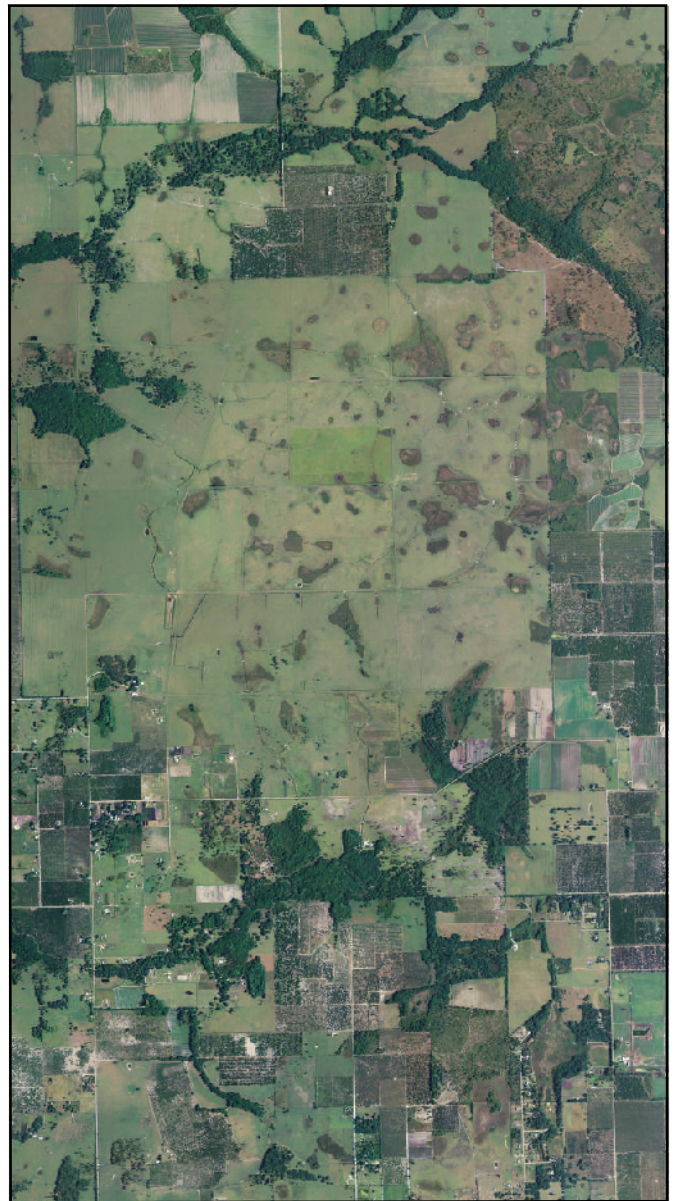
**Figure 3.11**

# South Fort Meade Wetlands Comparison

production; create more upland pastures for increased beef cattle production; prepare land for residential, industrial, and commercial development; strip mine an area for phosphate; and control mosquitoes. Extensive wetland drainage in the upper sub-basin is documented as early as 1915. Following World War II, agricultural expansion accelerated throughout the watershed. Examples of more recent agricultural land use impacts on wetlands that have occurred in the Peace River basin are shown in Figures 3.11 and 3.12.
