Clower Creek Stream Assessment

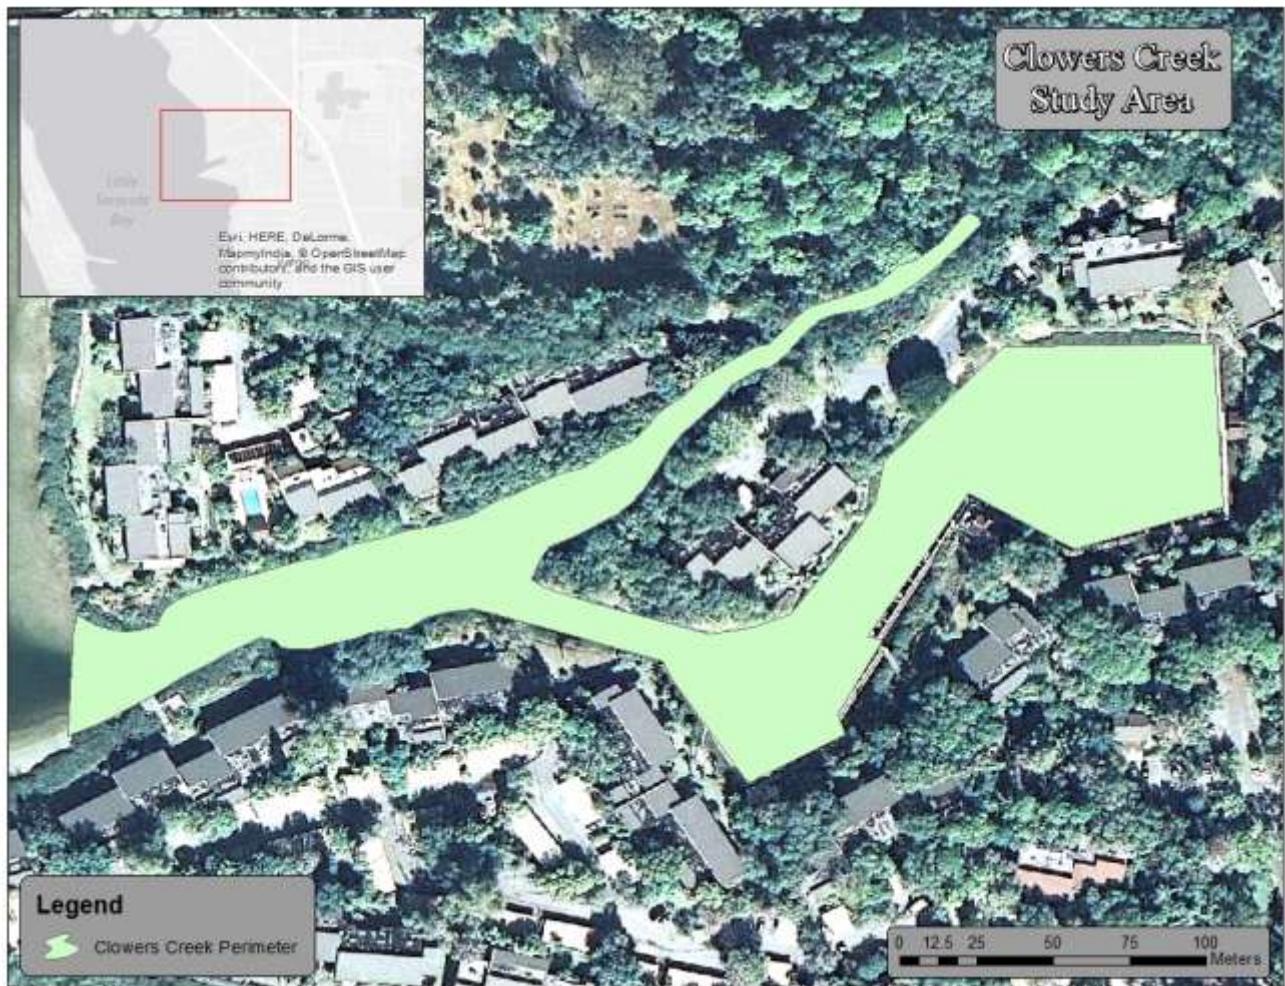
Figure 21. Overview of the Clower Creek Study Area

Clower Creek was assessed on August 29, 2014. Clower Creek is in a highly urbanized watershed with residential (53%), commercial (10%) and industrial (8.15%) land use. This creek is located in Sarasota County south of downtown Sarasota. The upstream portion of Clower Creek has been straightened between the weirs and Vamo Road. The watershed for Clower Creek has an LDI value of 30.08 from the urbanization in the surrounding areas. Clower Creek flows into Little Sarasota Bay.

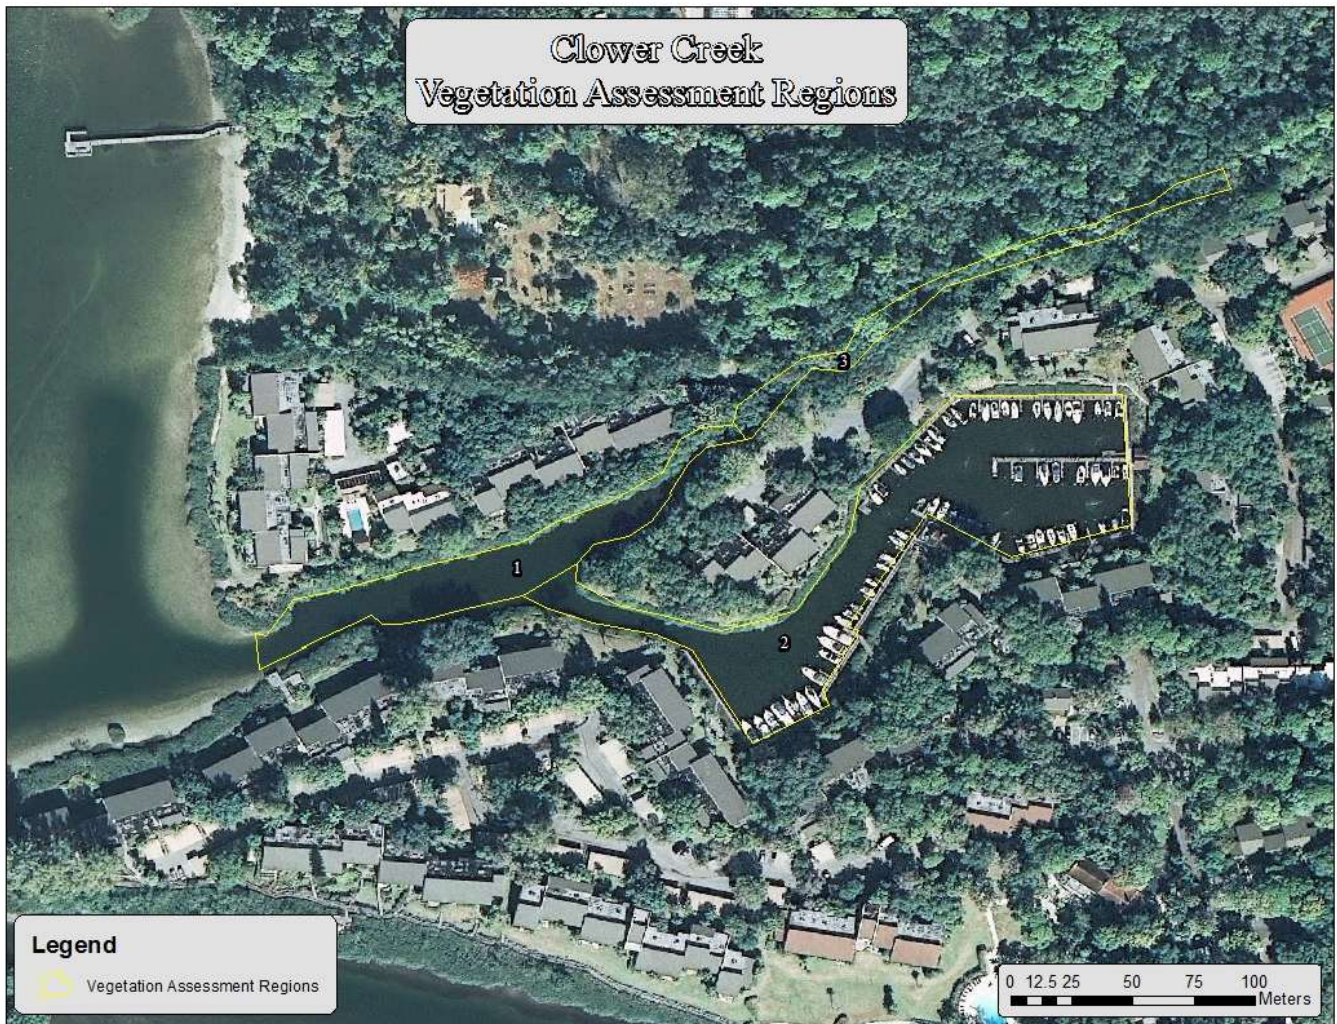
Figure 22. Overview of Clower Creek Vegetation Assessment Regions

The Clower Creek vegetation assessment encompassed 3 vegetation regions from the mouth in Little Sarasota Bay as shown in Figure 22. In these regions, 16 species of vegetation were identified. Regions 1 and 2 were dominated by mangroves with few other salt tolerant species present. The first occurrence of Leather Fern (*Acrostichum danaeifolium*) was in Region 3. Above Region 3 the vegetation communities are dominated by Brazilian Pepper (*Schinus terebinthifolius*), Leather Fern (*Acrostichum danaeifolium*) and White Mangrove (*Laguncularia racemosa*).

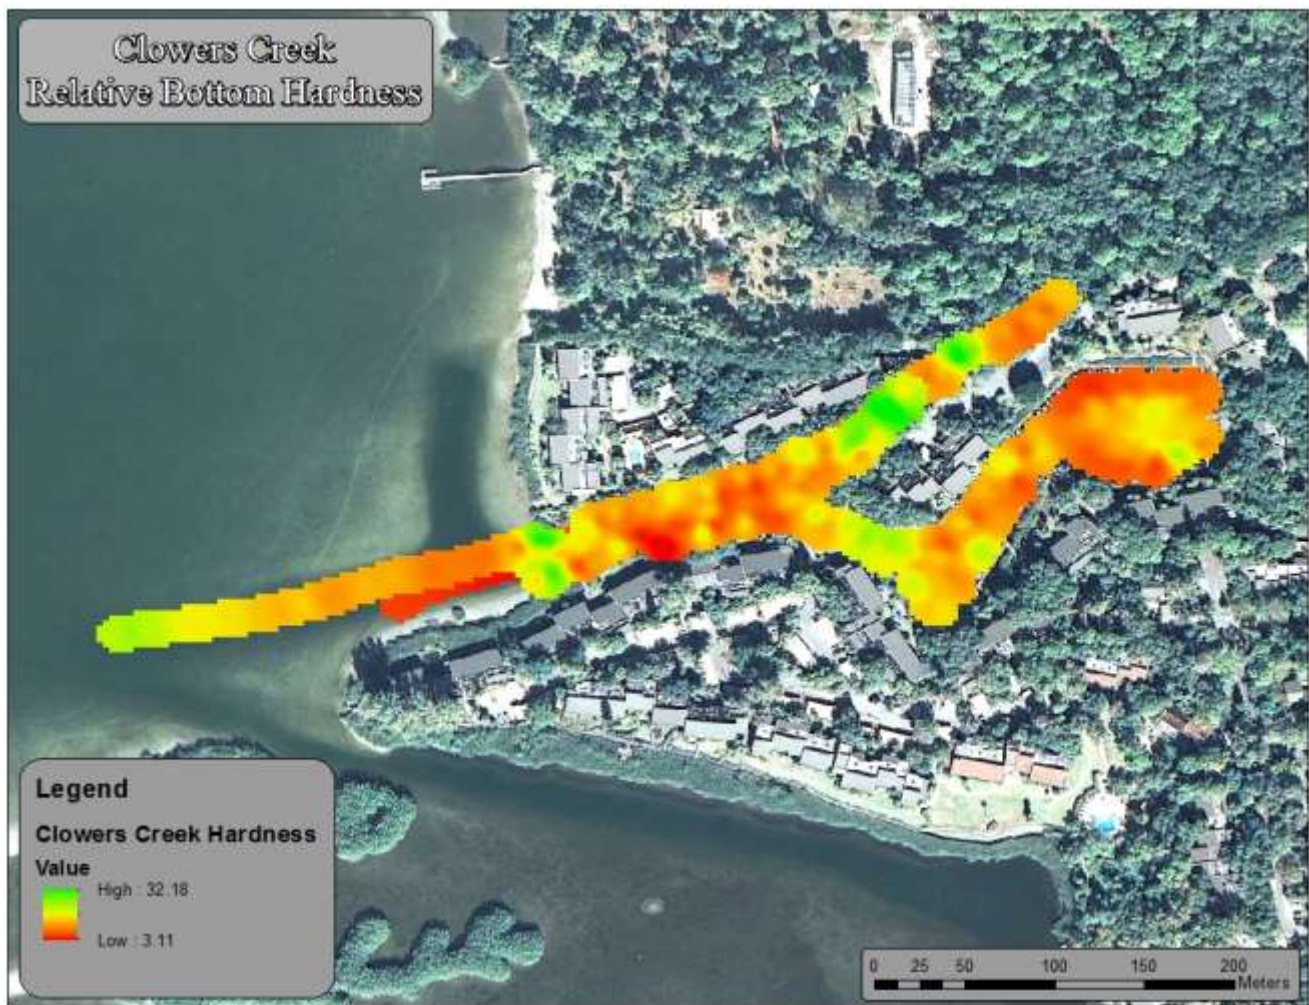
Figure 24. Clower Creek Relative Bottom Hardness Map

Collected sonar data were processed through Dr. Depth software to analyze the strength of the return signal from the bottom to get an estimate of the relative bottom hardness for Clower Creek. Figure 24 shows the bottom hardness raster for Clower Creek. This map is meant to help identify locations of harder and softer bottoms for benthic invertebrate sampling, fish sampling and benthic chlorophyll sampling.

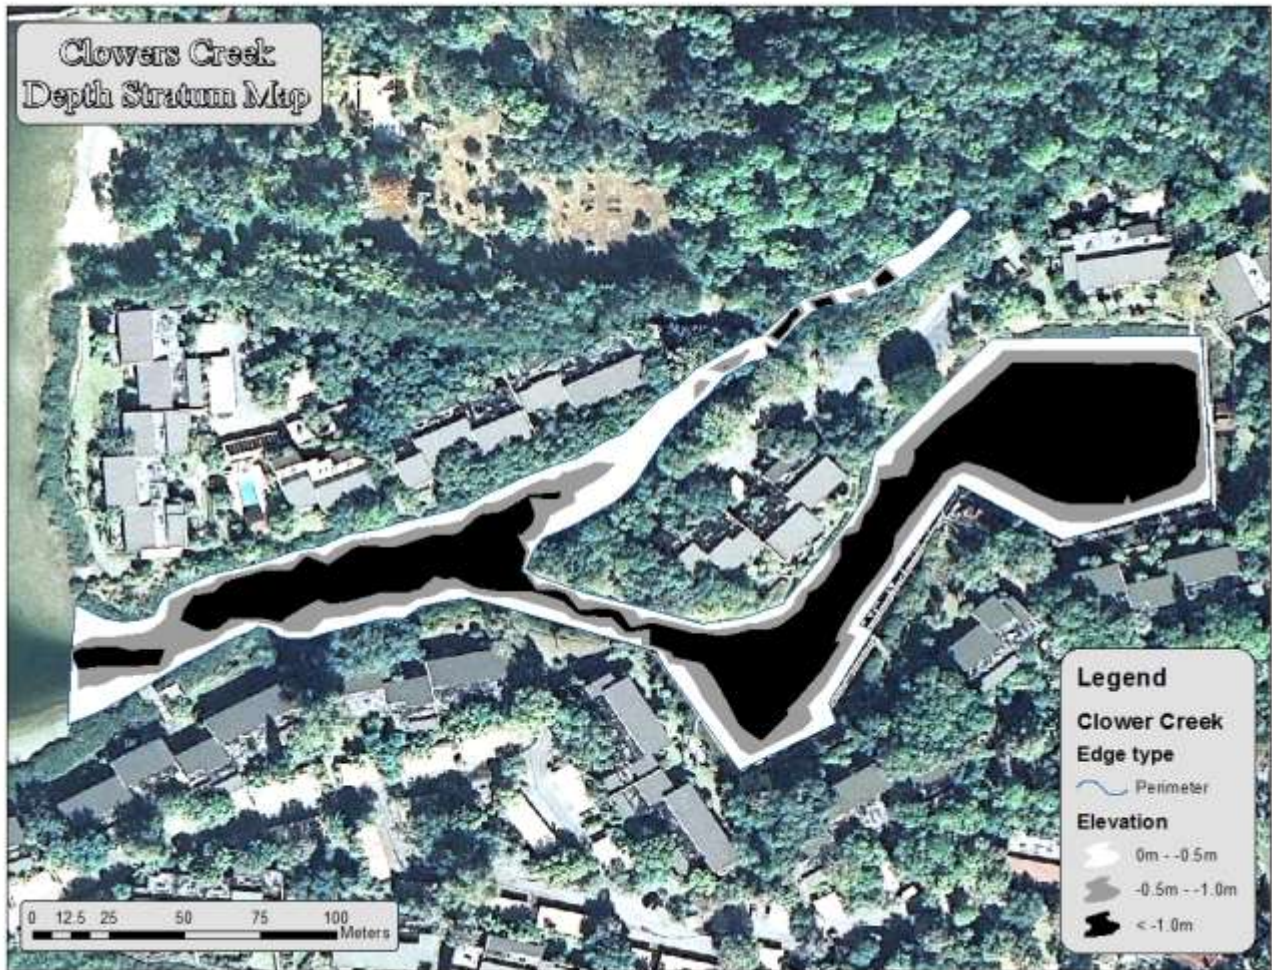
Figure 25. Clower Creek Bathymetric Stratum Map

In the study area, Clower Creek had a mean depth of 3.15 feet and a maximum depth of 6.74 feet. A total of 3.47 acres of creek was mapped during the assessment. At the time of assessment, Clower Creek contained an estimated 3,280,563 gallons of water in the study area. The water level elevation at the time of the assessment was 4.24 feet at Sarasota ARMS CLO-1 station. Figure 27 details the bathymetric mapping for Clower Creek showing the three depth strata.
