North Creek Stream Assessment

Study Area

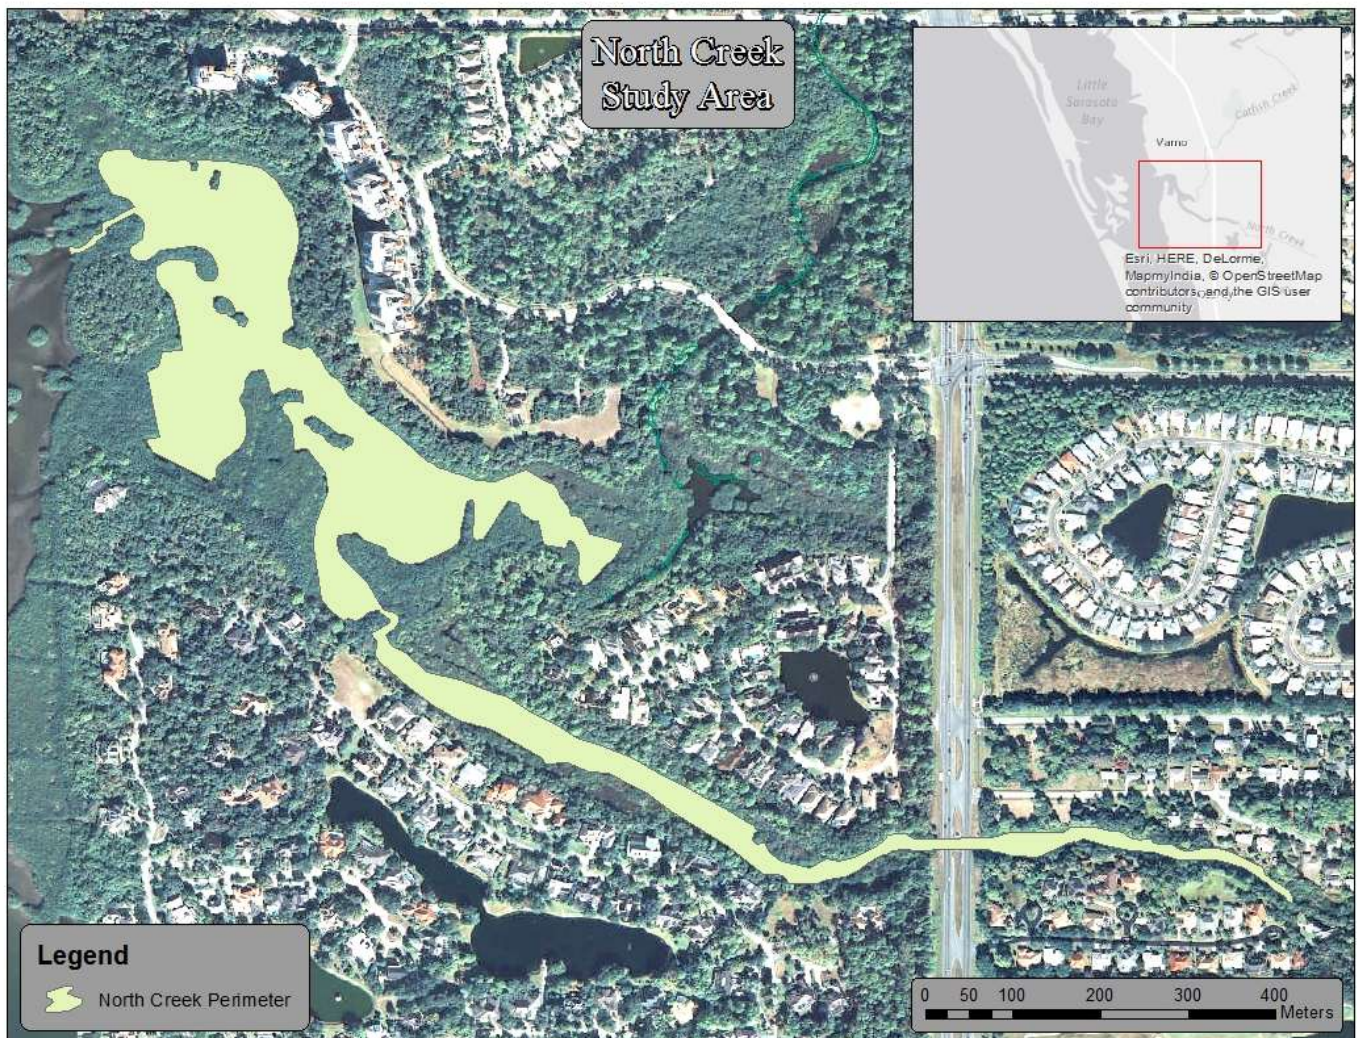
Figure 26. Overview of the North Creek Study Area

North Creek was assessed on September 3, 2014. North Creek is located in the Little Sarasota Bay Watershed in Sarasota County as shown in Figure 26. The North Creek watershed is dominated by residential (44.69%), natural land/open water (18.85%) and golf courses (14.41%). The watershed of North Creek has an LDI value of 29.21. North Creek's banks have little development and are naturally sloping with a vegetative border.

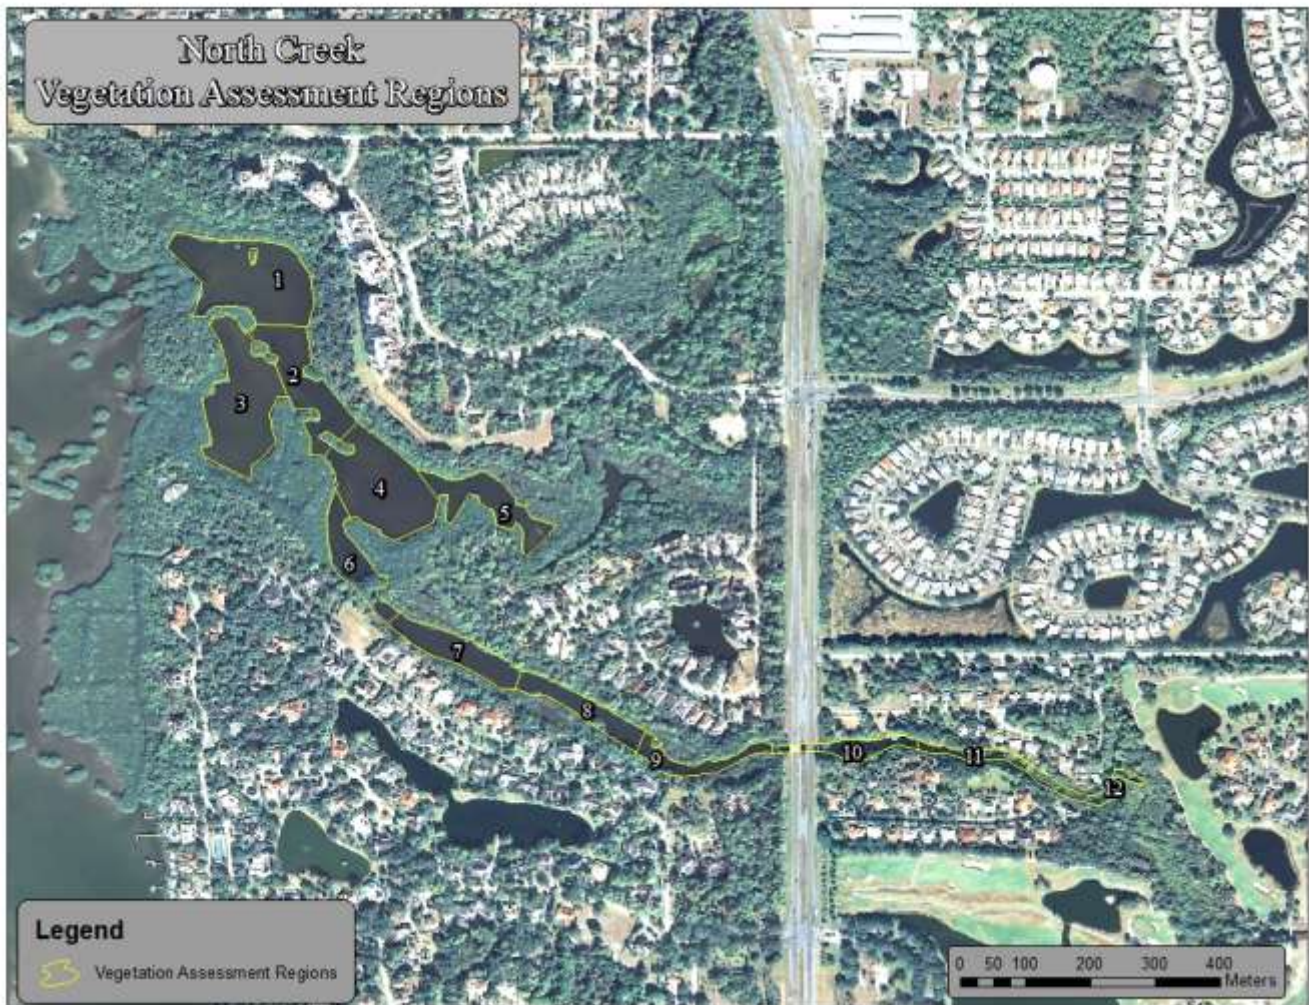
Figure 27. Overview of North Creek Vegetation Assessment Regions

The North Creek vegetation assessment encompassed 12 vegetation regions from the mouth in Little Sarasota Bay to upstream from U.S. Highway 41 as shown in Figure 27. In these regions, 34 species of vegetation were identified. Regions 1 through 6 were dominated by mangroves (*Rhizophora mangle*, *Laguncularia racemosa* and *Avicennia germinans*) with few other salt tolerant species present. The first occurrences of Leather Fern (*Acrostichum danaeifolium*), Cattails (*Typha*) and Needle Rush (*Juncus roemerianus*) were in Region 7. Common Bacopa (*Bacopa monnieri*) was first observed in Region 8. Above Region 12 was not accessible due to the creek being blocked by mangroves and Brazilian Pepper (*Schinus terebinthifolius*).

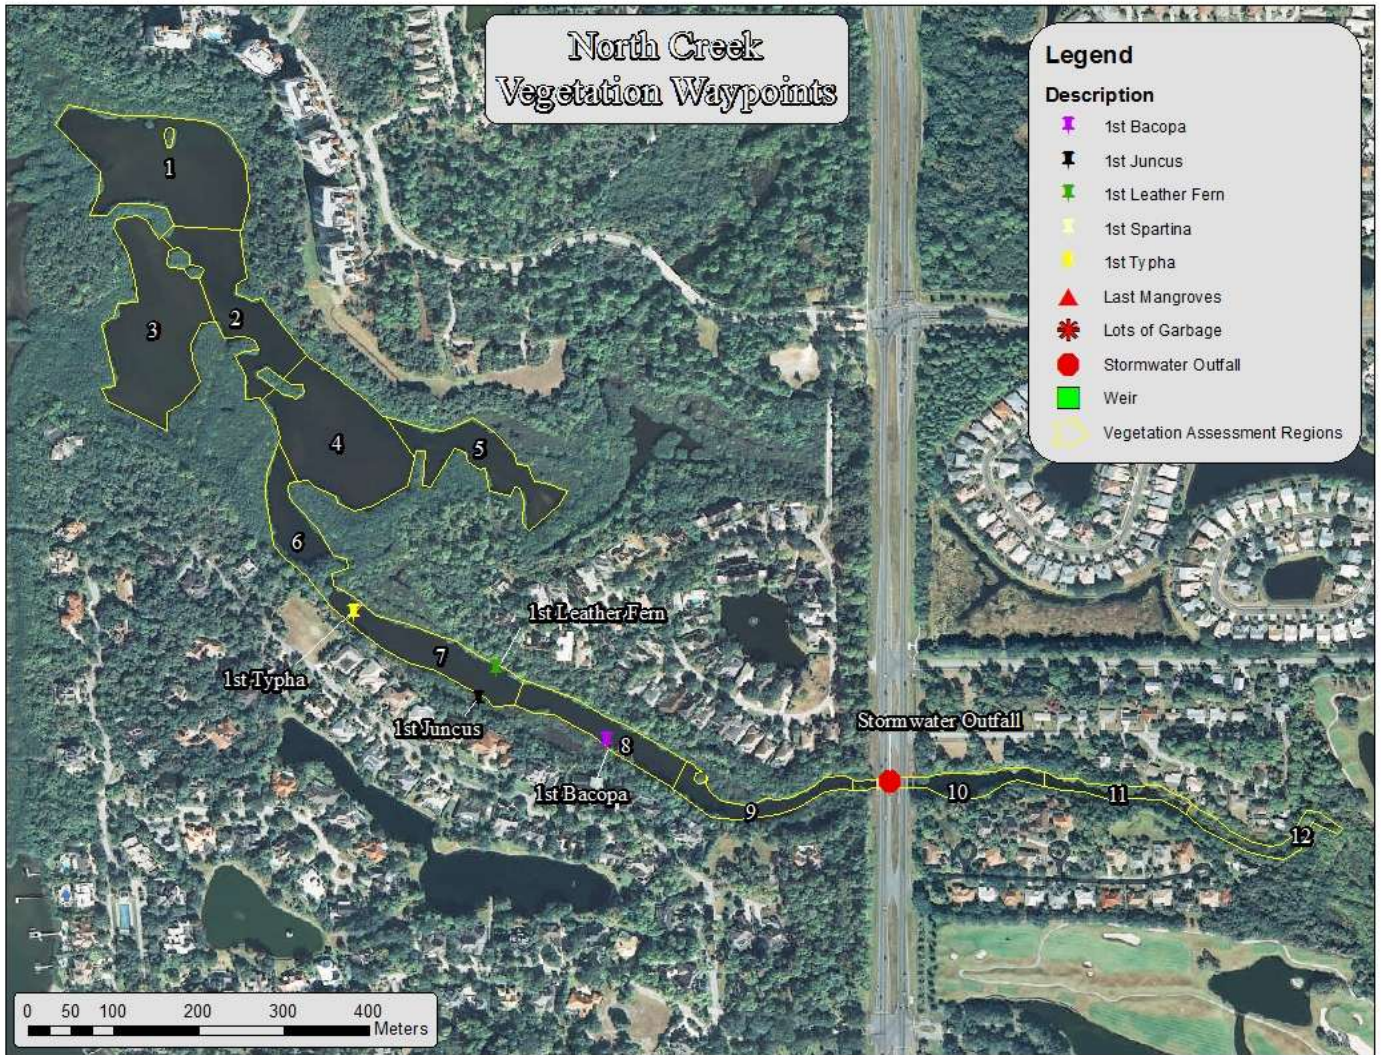
Figure 28. North Creek Vegetation Waypoints

Figure 28 shows the vegetation transition zone of North Creek indicating the most downstream Leather Fern, *Bacopa*, *Typha* and *Juncus*. Based on the vegetation assessment data for North Creek, Regions 1 through 6 would comprise the highest salinity and tidal influence zone, Regions 7 through 12 would comprise the “mixing” zone and above Region 12 would comprise the freshwater dominant zone. The vegetation assessment species lists are shown in Tables 6 through 8.

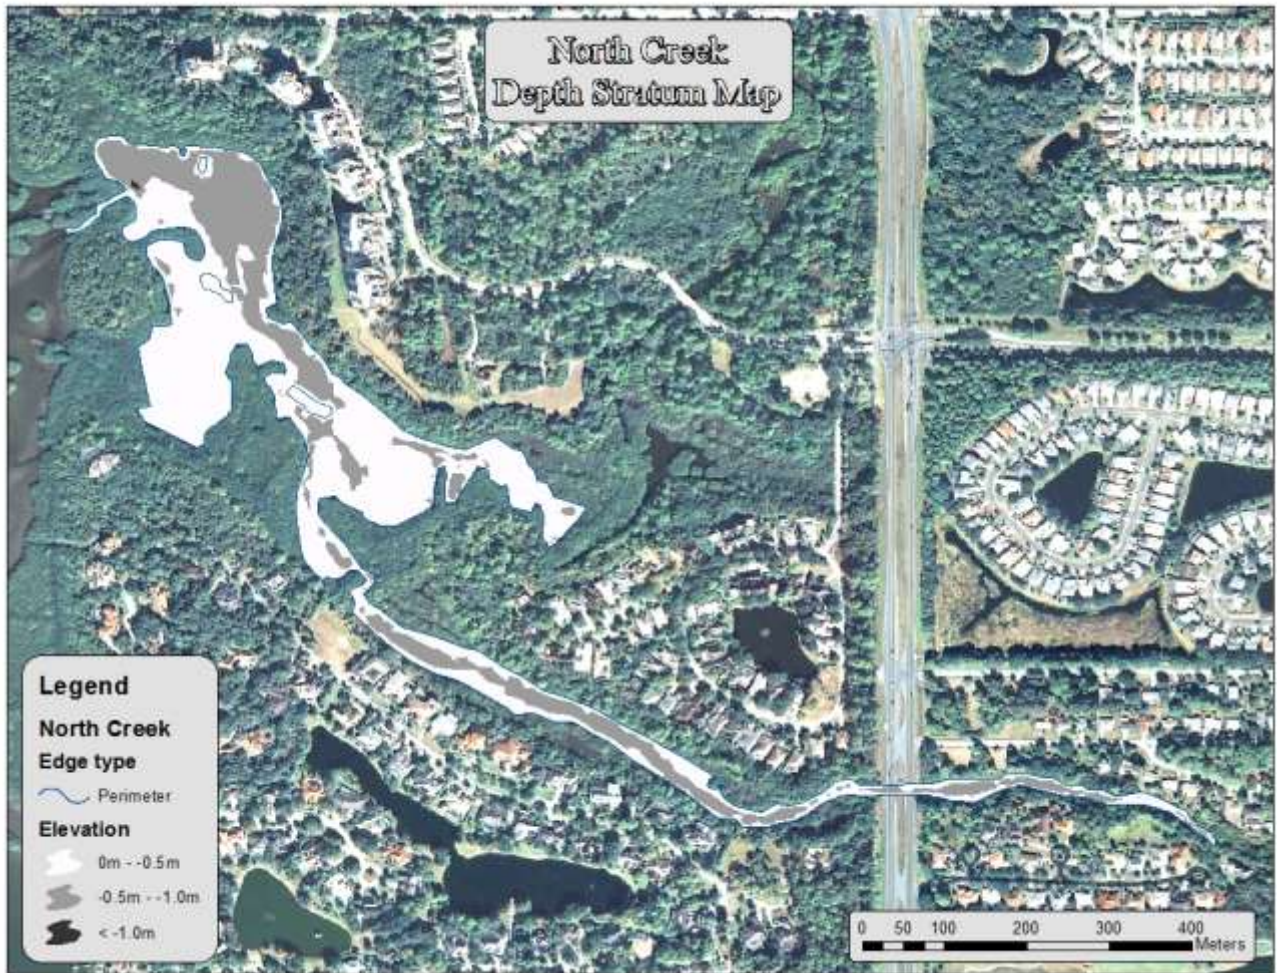
Figure 30. North Creek Bathymetric Stratum Map

In the study area, North Creek had a mean depth of 1.74 feet and a maximum depth of 5.52 feet. A total of 25.23 acres of creek was mapped during the assessment. At the time of assessment, North Creek contained an estimated 11,629,899 gallons of water in the study area. The water level elevation was 4.75 at Sarasota ARMS NO-1 station at the time of the assessment. Figure 30 details the bathymetric mapping for North Creek showing the three depth strata.
