Whidden Creek Stream Assessment

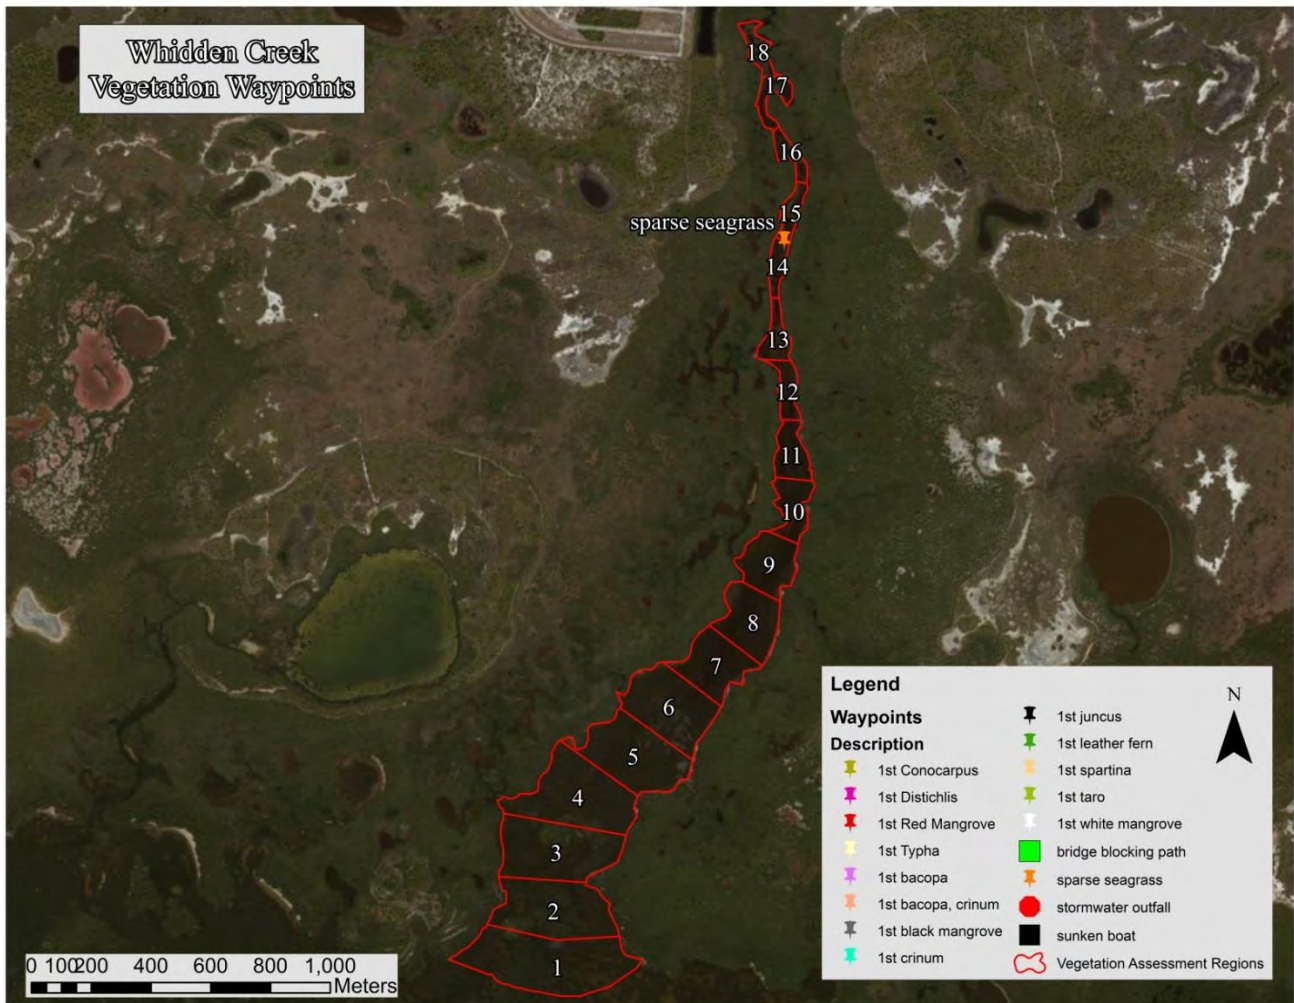
Figure 64. Whidden Creek Vegetation Waypoints

Figure 64 shows the vegetation transition zone of Whidden Creek indicating the most upstream seagrass. Based on the vegetation assessment data for Whidden Creek, regions 1 through 3 would comprise the highest salinity and tidal influence zone due to the presence of Turtle Grass, regions 4 through 14 would comprise the “mixing” zone due to the presence of Widgeon Grass and regions 15 through 18 would comprise the least saltwater dominant zone. The vegetation assessment species list is shown in Table 16.
